# SITE REVISIONING PLAN

107 NORTH GARNAVILLO STREET  
ANAMOSA, IOWA

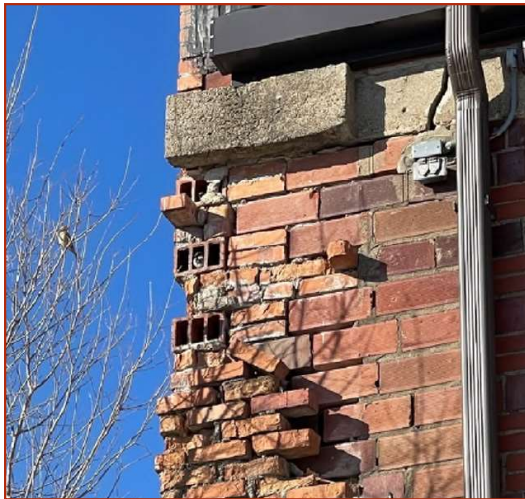
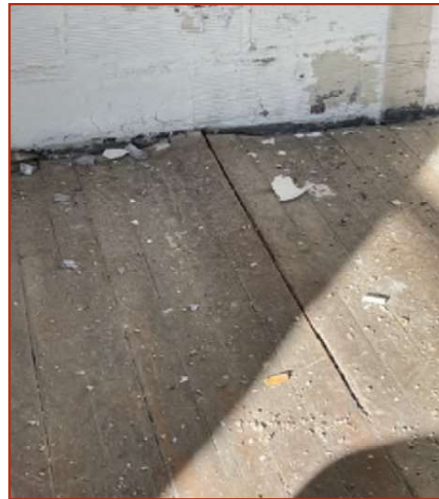
- The exterior walls on the sides and rear of the building have severely deteriorated mortar joints and support beams above the windows.
- The interior of the building was in better shape, with only a few minor instances of buckling in the wood plank floor, and the wood framing was in good condition.
- The basement of the building was in fair condition, with some cracking noted on the north foundation wall and southeast exterior corner of the foundation.
- The structural assessment recommended tuckpointing the exterior mortar joints, repairing and replacing any loose bricks, and the concrete support lintels above the windows.

*Failing exterior bricks on exterior wall and buckling of hardwood flooring. Source: Select Structural*

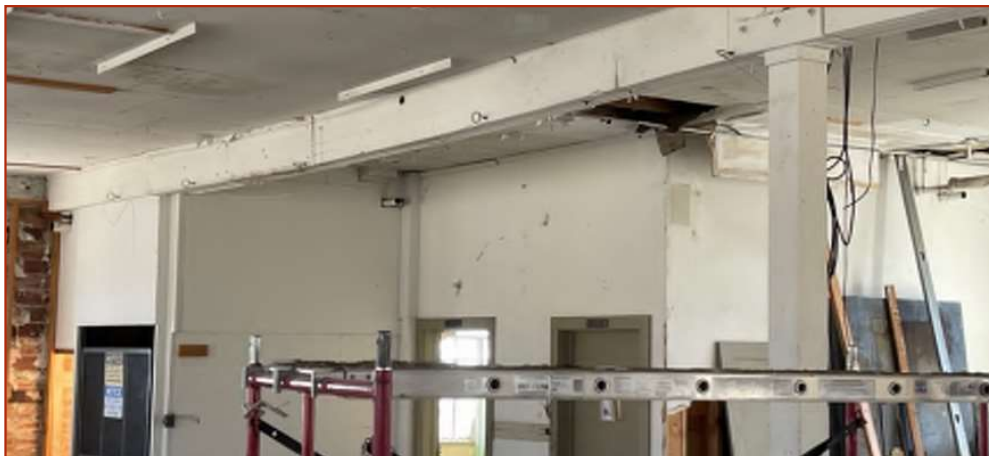
*Sagging beam supporting roof near the elevator shaft. Source: Select Structural*

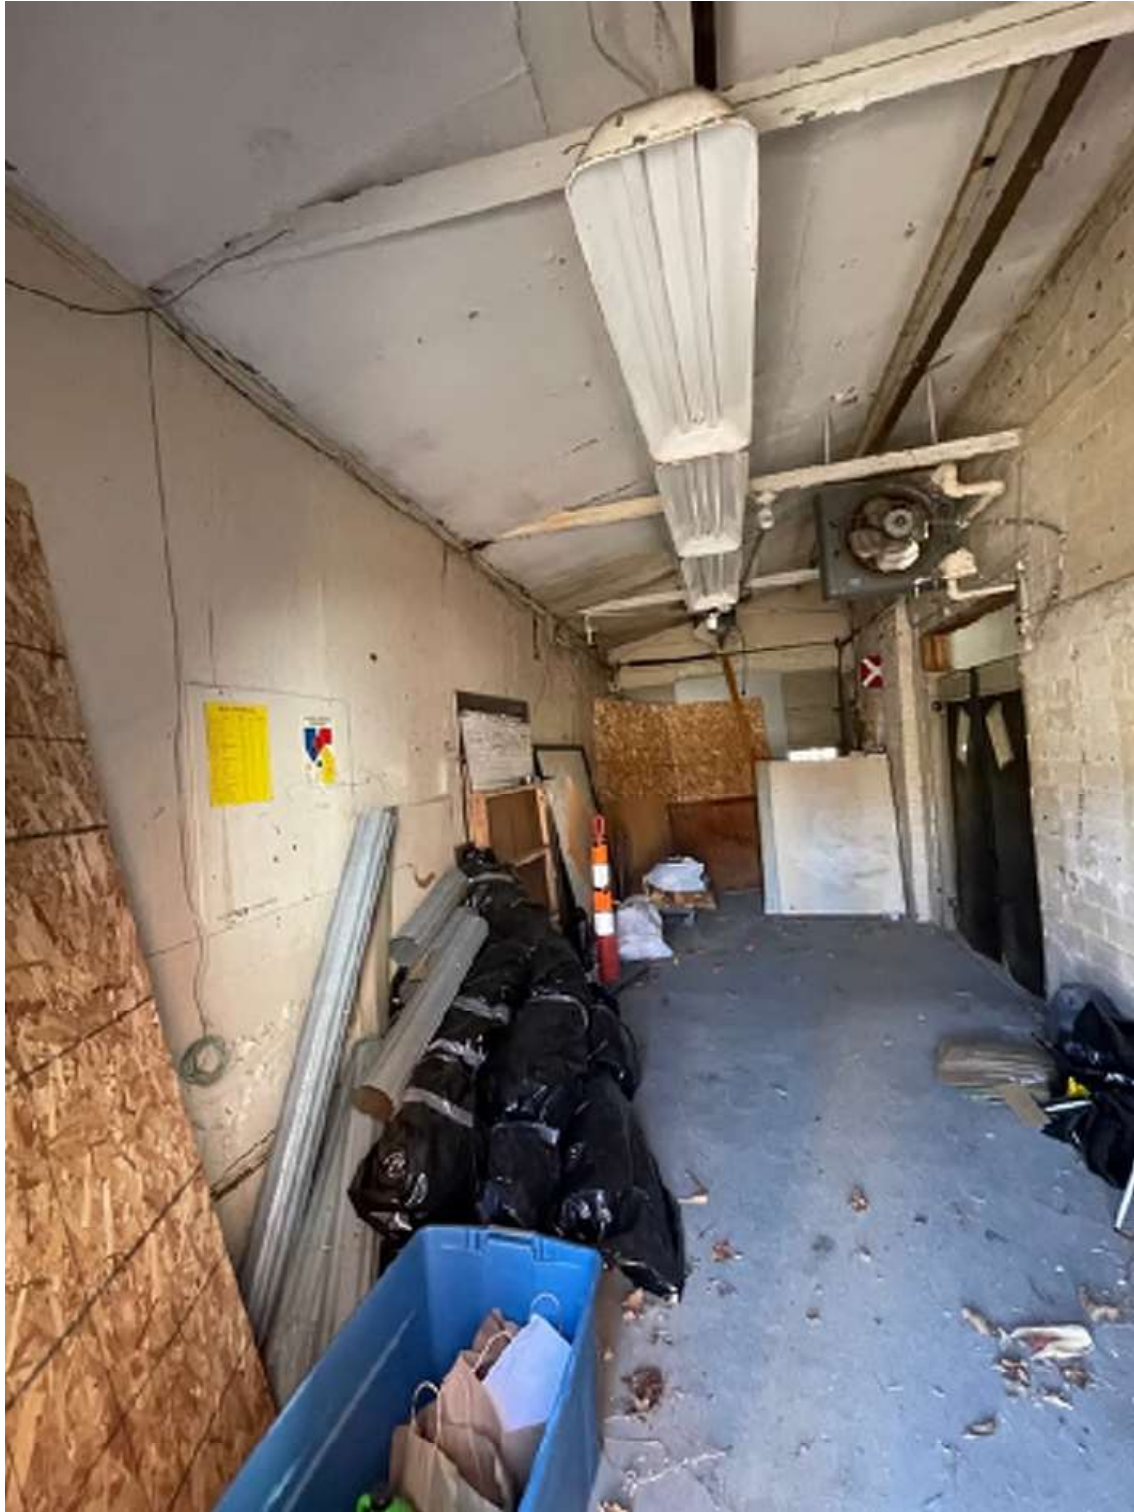
Photo 3 – A wood framed “Lean-to” addition was found on the rear (East) side of Building and was in average condition. Much of the structure was covered and not exposed for review.

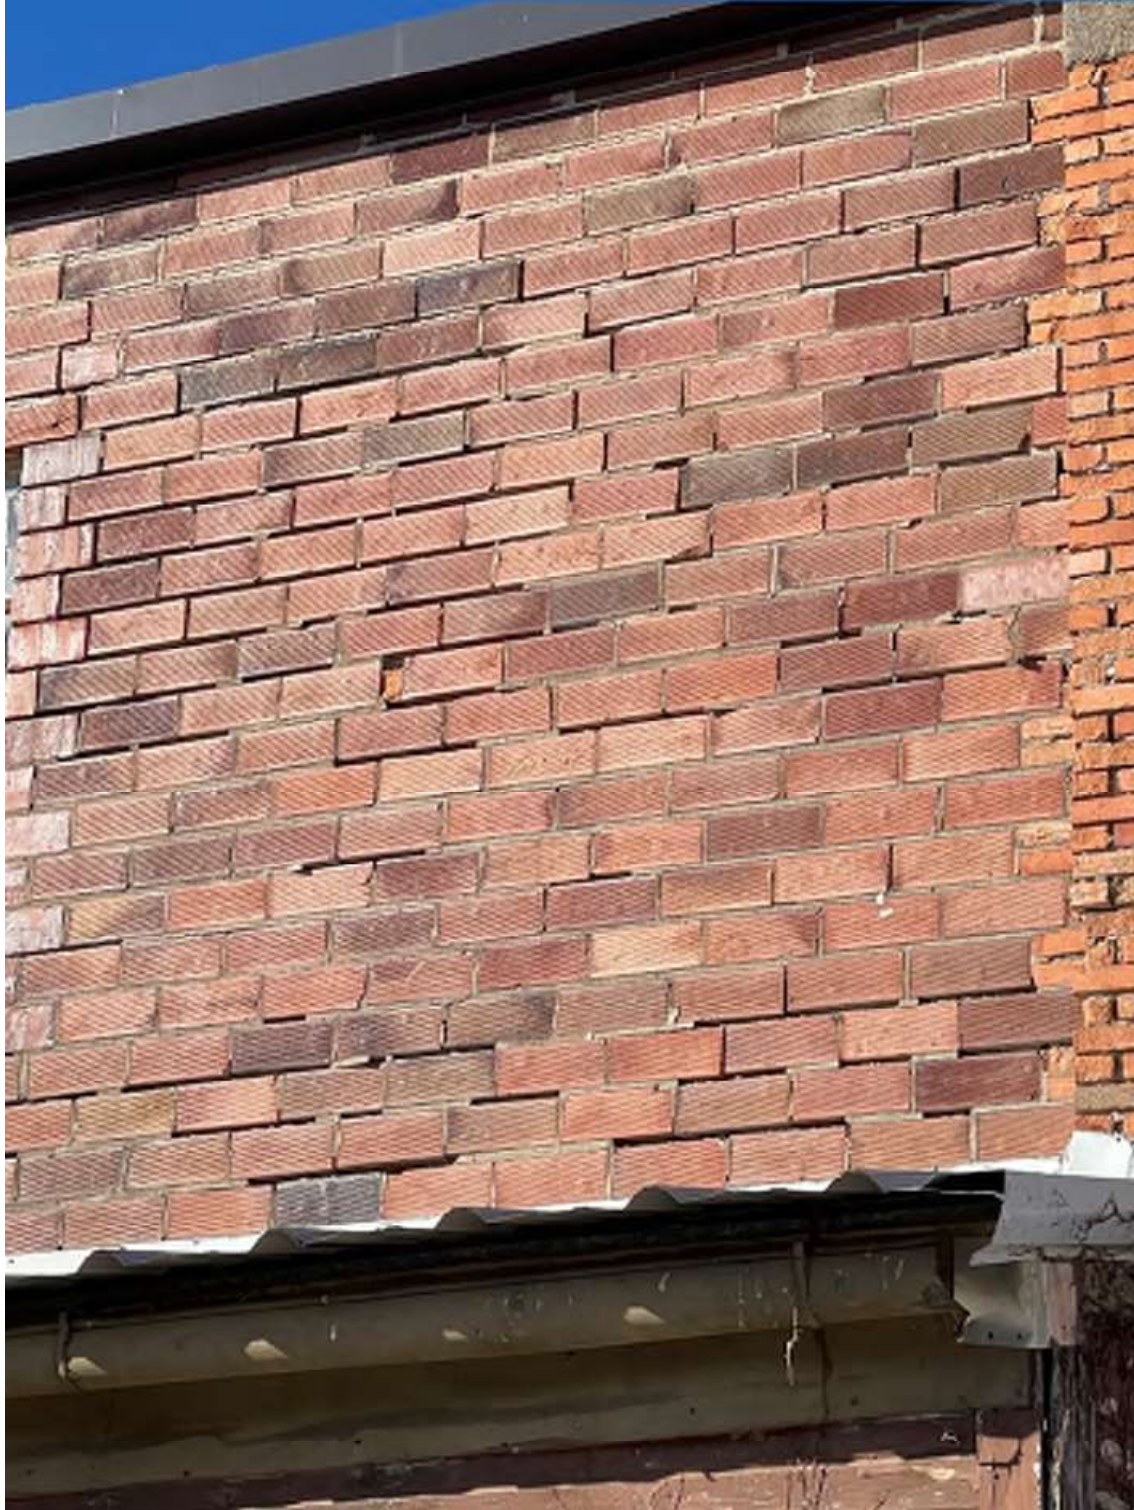
Photo 4 – Typical example of deterioration in mortar joints of exterior wall

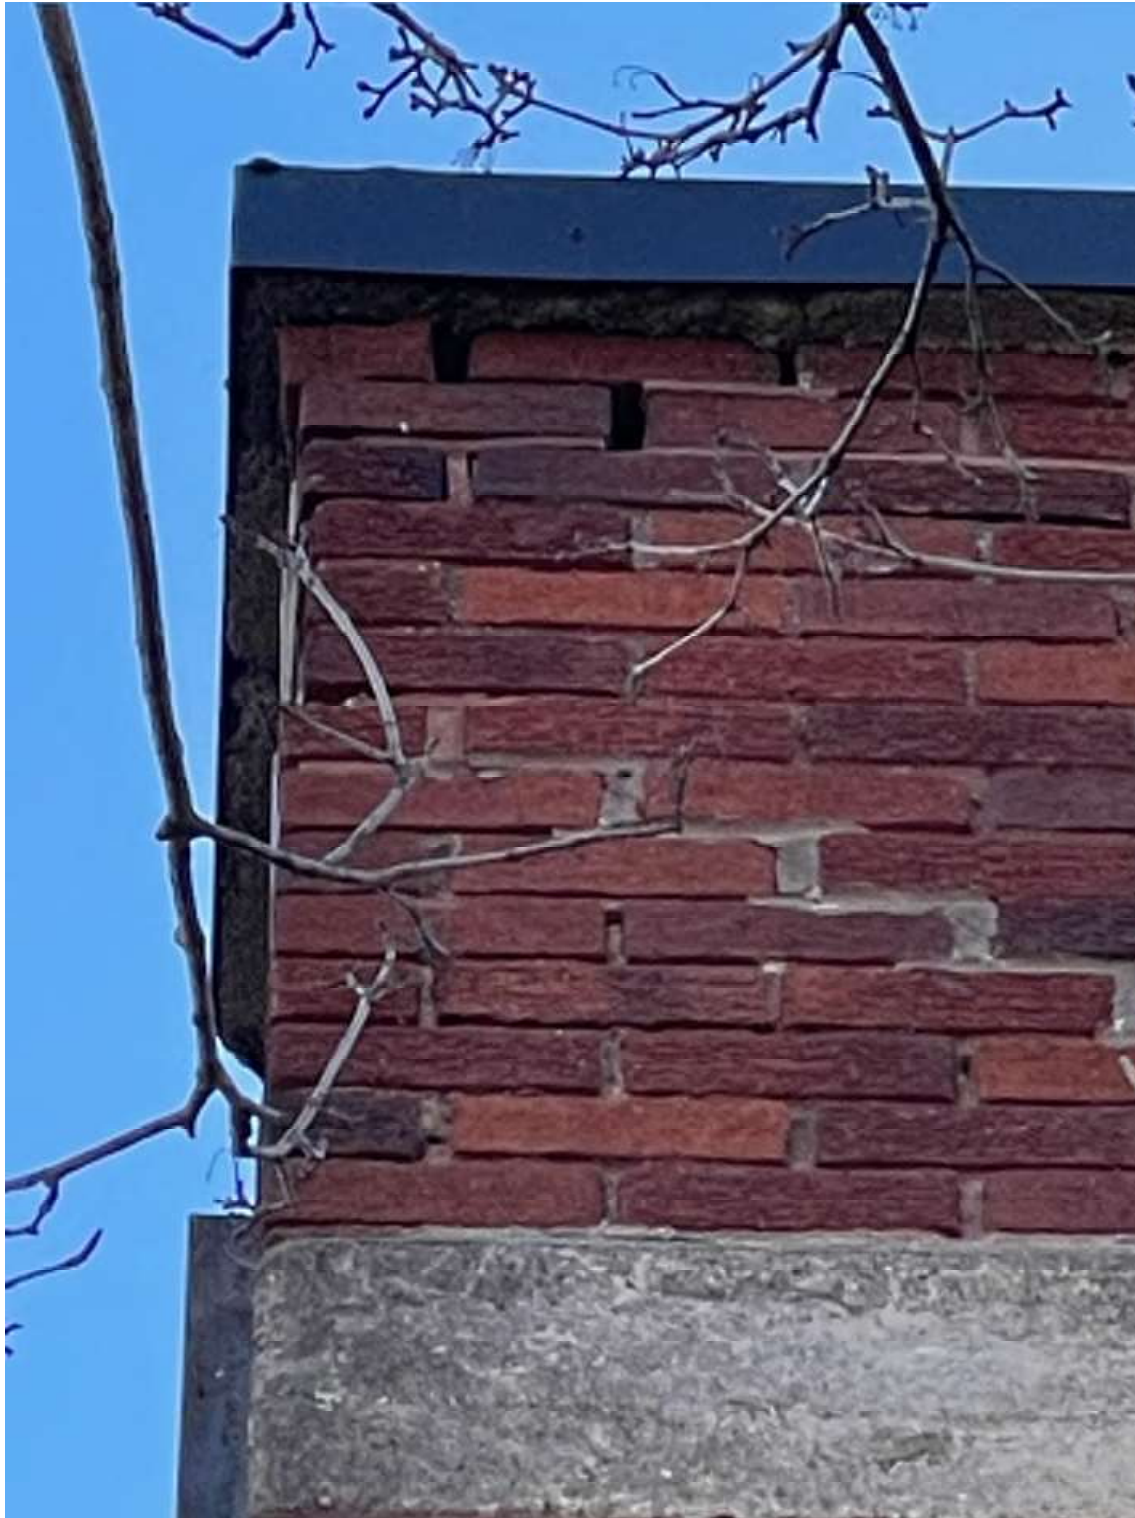
Photo 5 - Loose bricks found at top corner of exterior wall. Non-structural façade, but should be re-set and mortar repaired during tuckpointing.

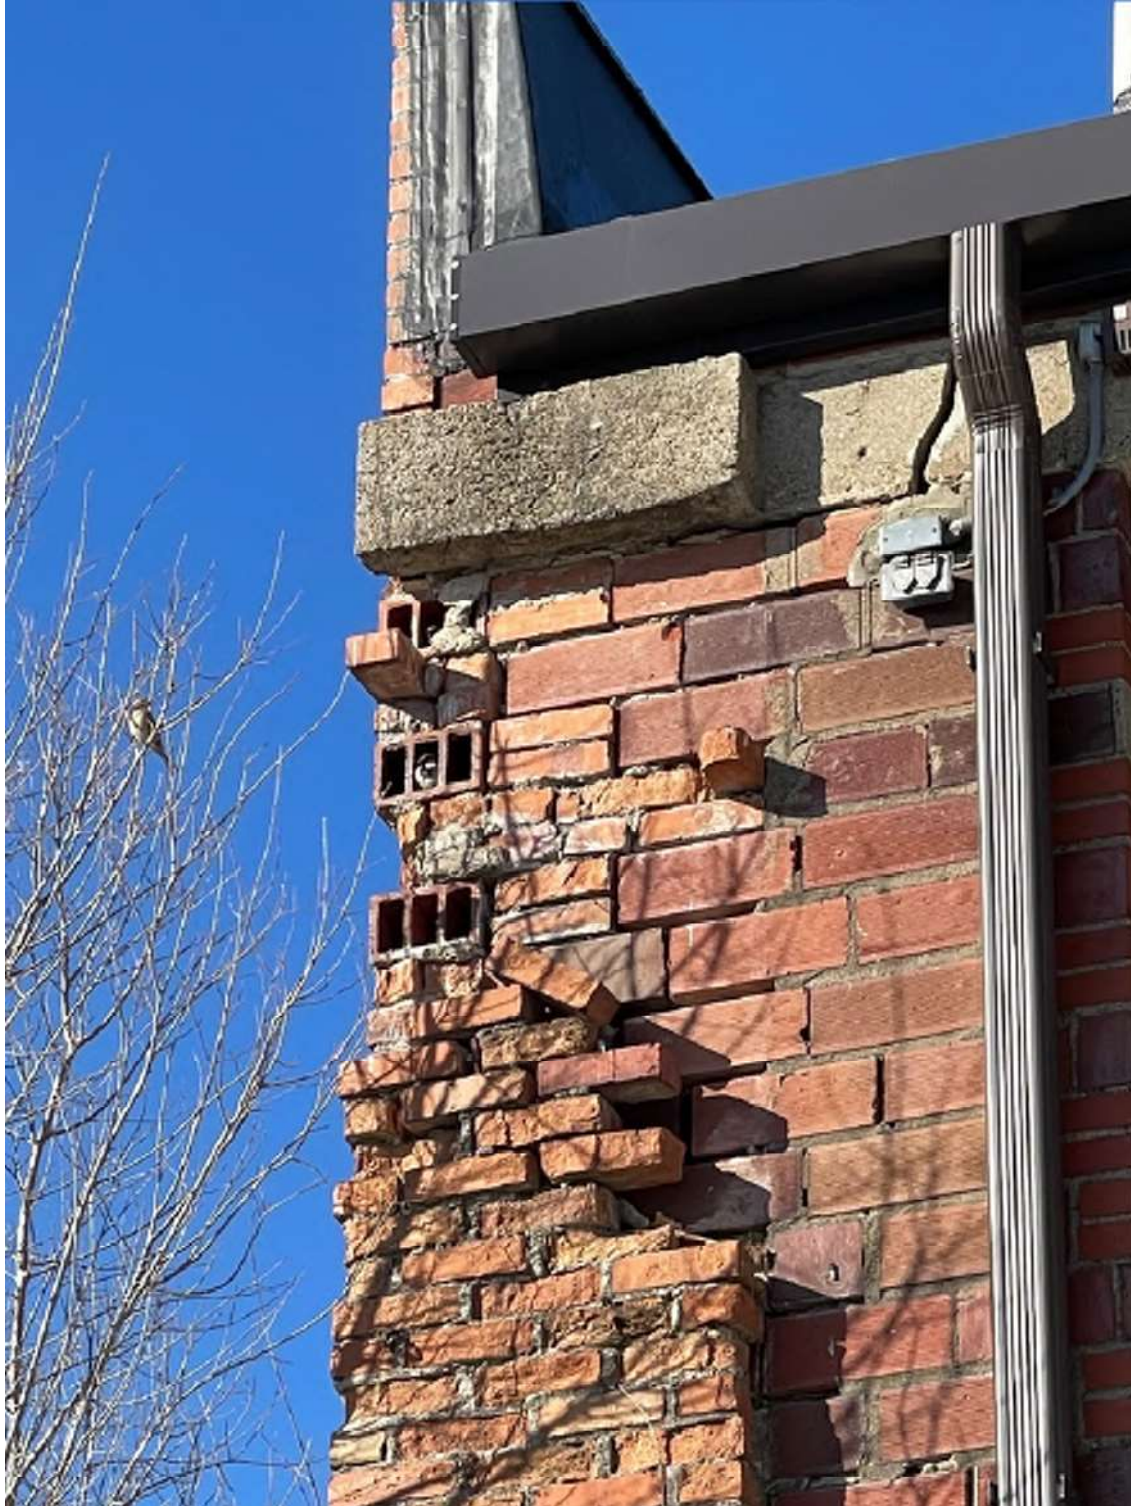
Photo 6 - Falling exterior bricks at Southeast corner of exterior wall. Recommend repairing and replacing as a part of the overall tuckpointing and masonry restoration operations.

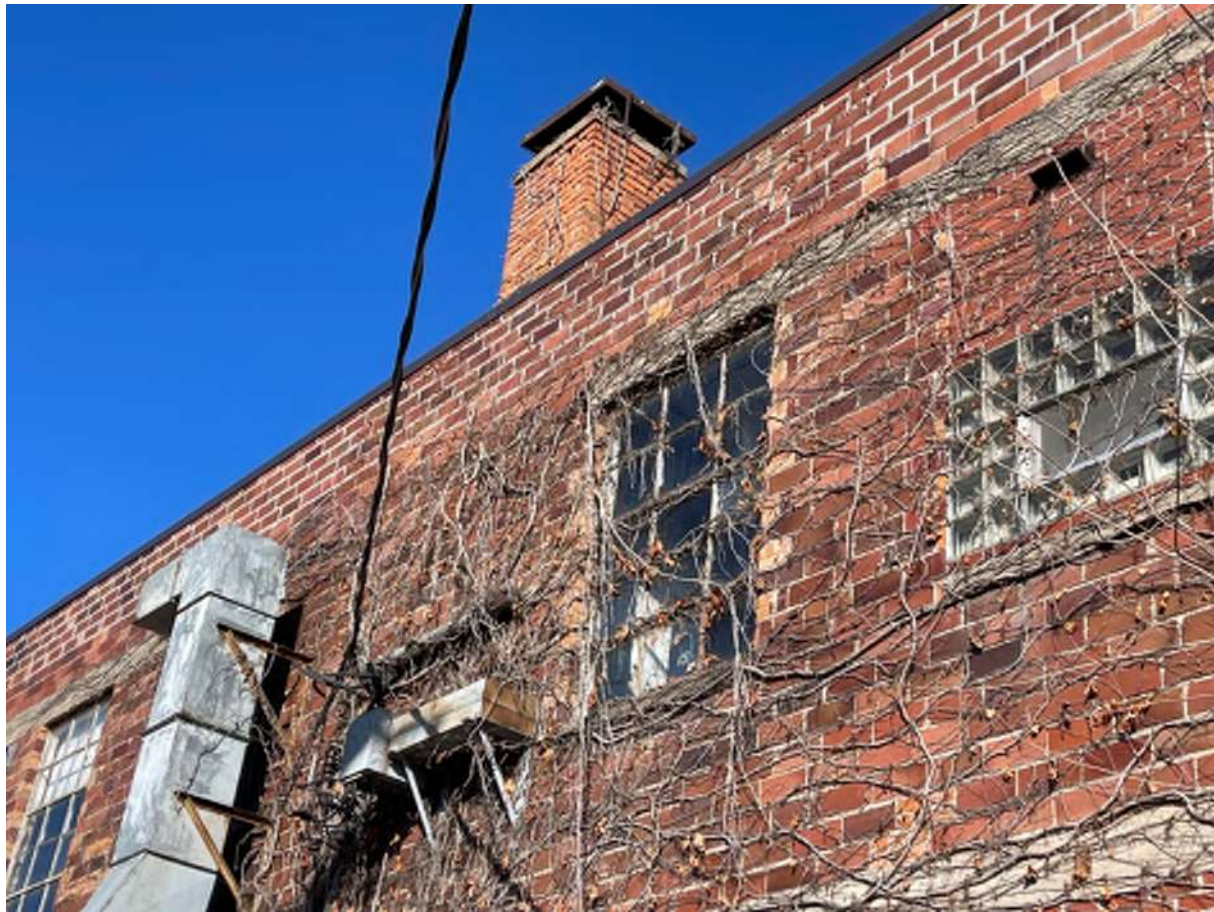
Photo 7 – East half of the South side exterior wall is covered with vines. Over time vines contribute to the deterioration of the masonry. Recommend killing and removing them.

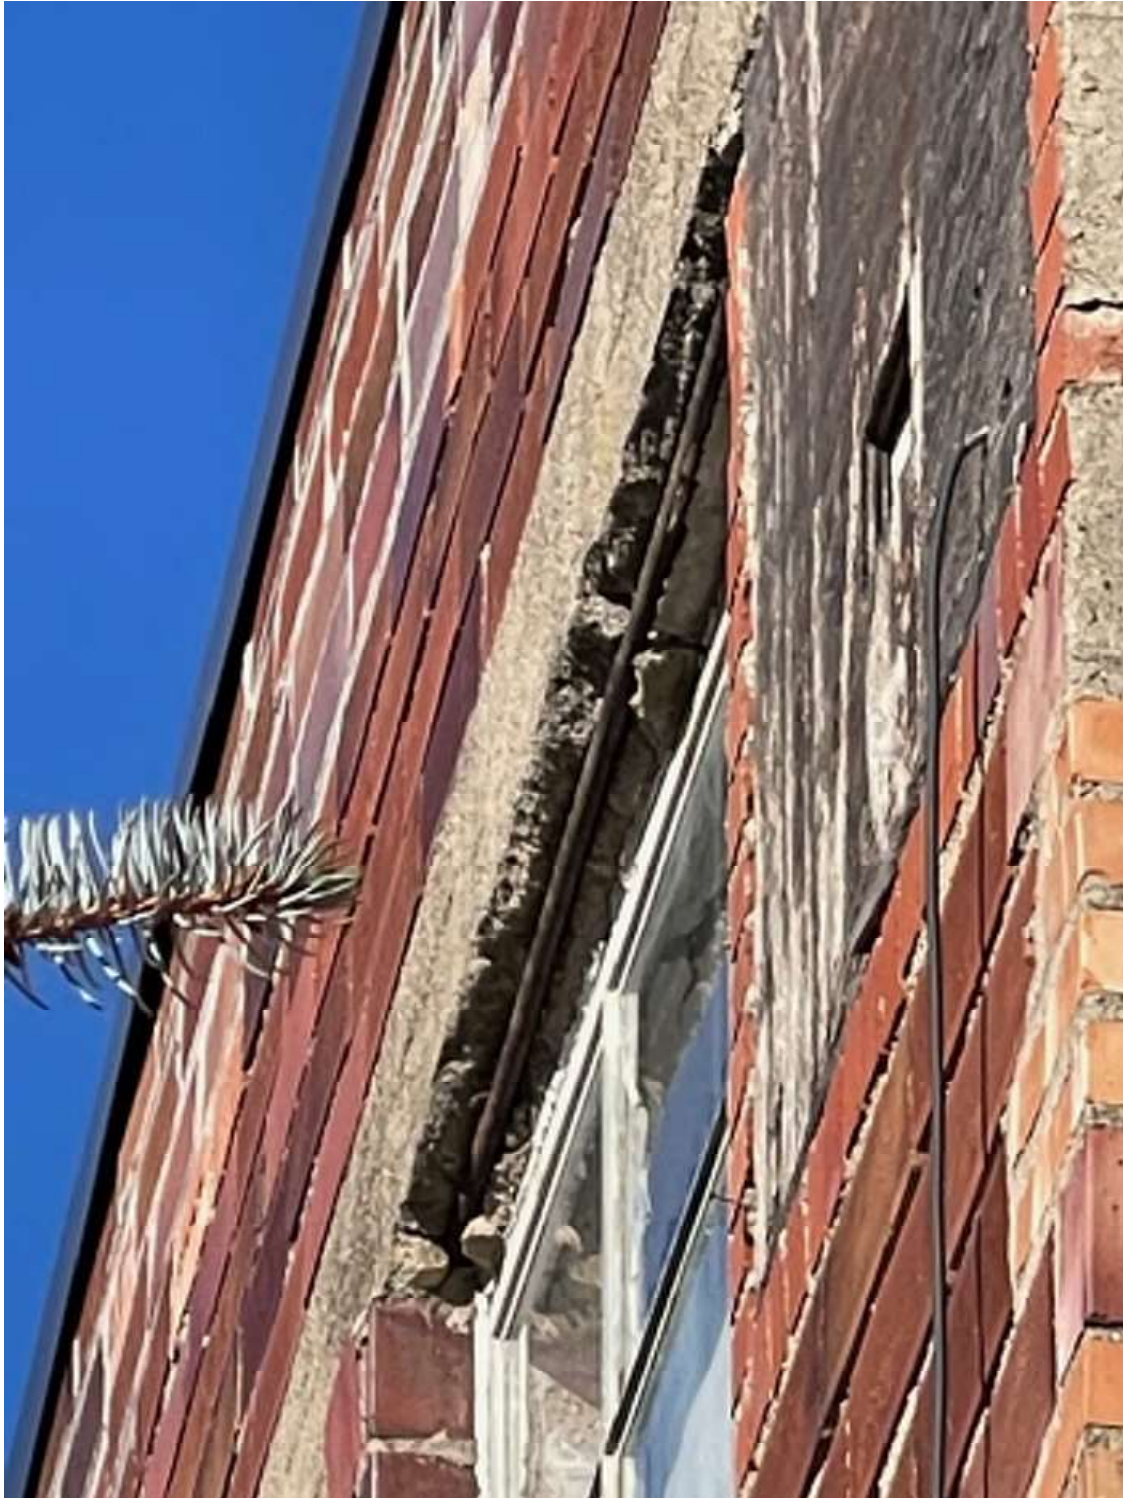
Photo 8 - Exposed structural rebar in concrete lintels that act as beams to carry the roof above the windows. Concrete has broken and fallen away. Recommend lintels be repaired and replaced as needed by the mason.

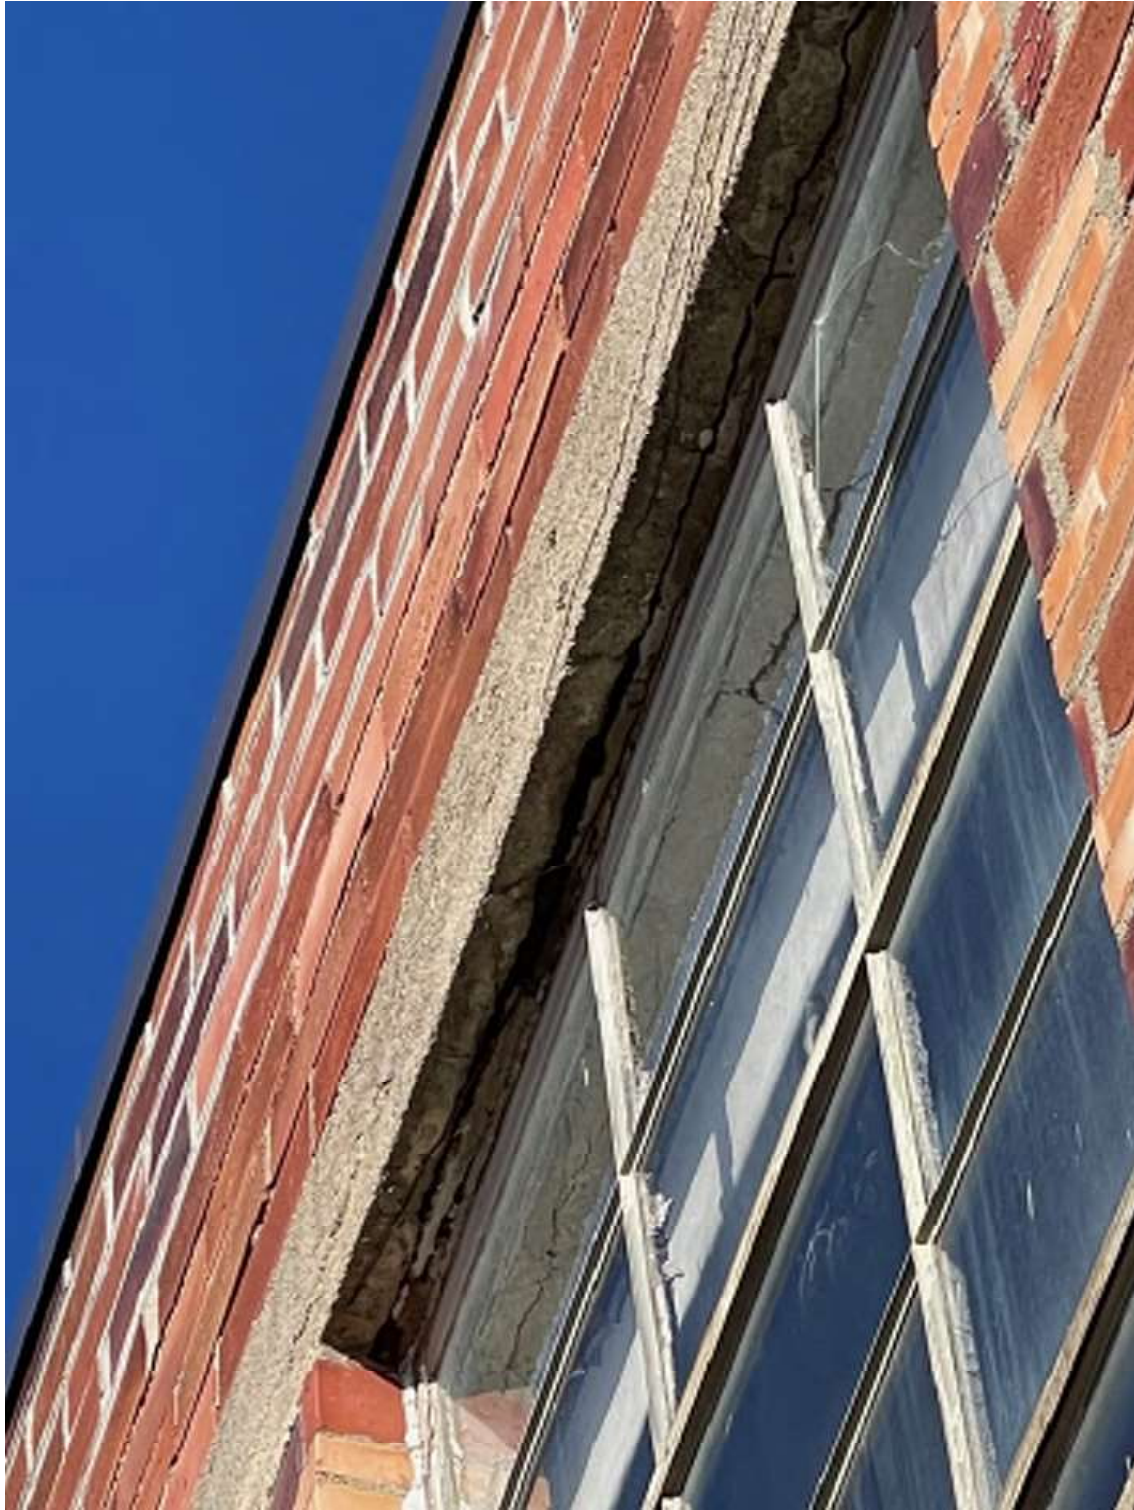
Photo 9 - Cracking and spalling of concrete lintels in need of repair.

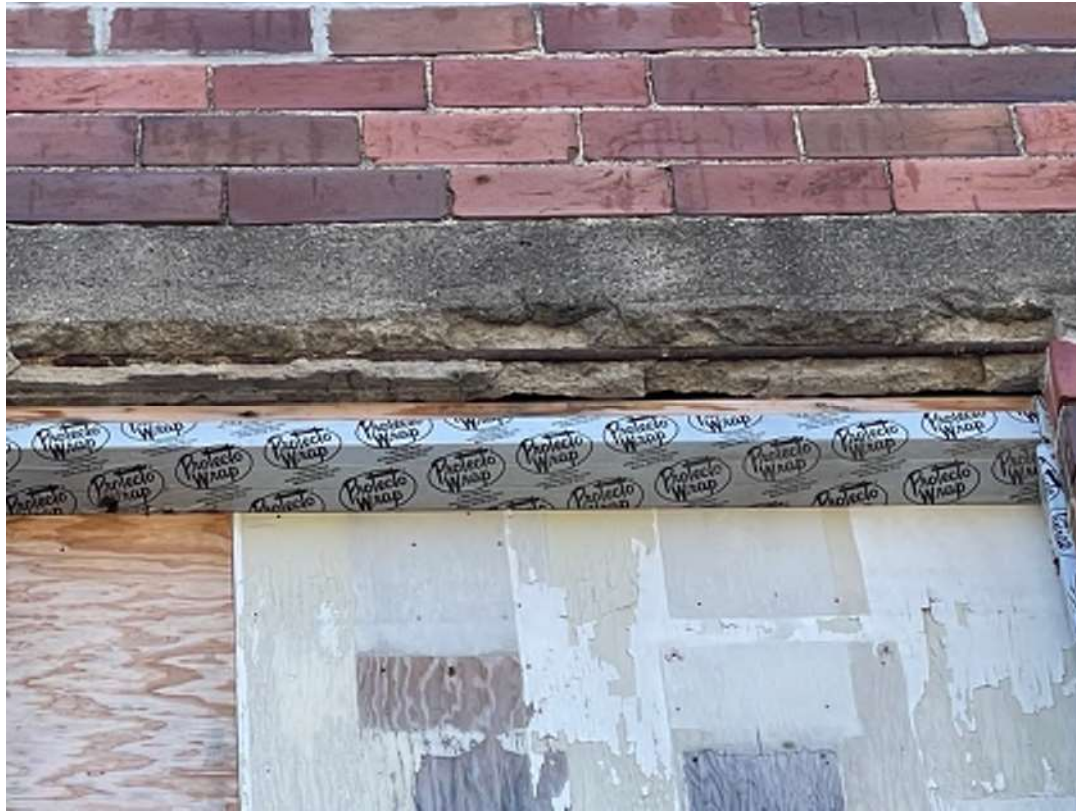
Photo 10 - Exposed rebar and falling concrete support beam/lintel

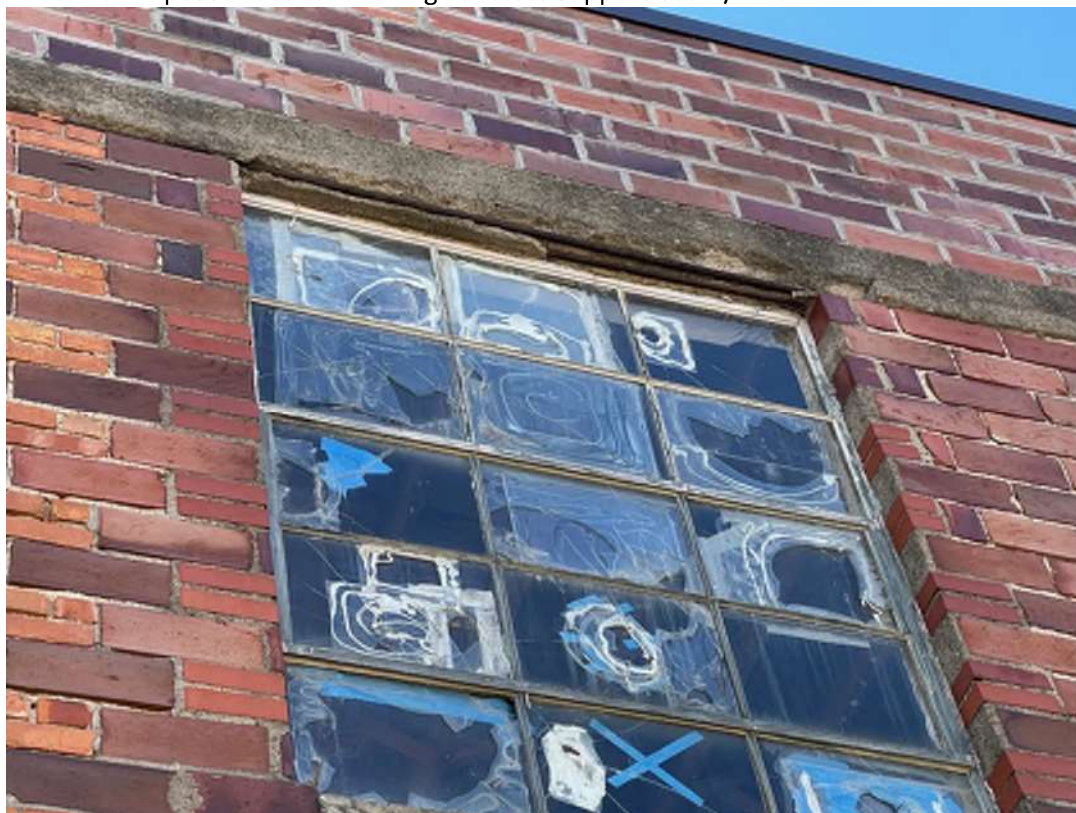
Photo 11- Exposed rebar and severe spalling of concrete lintel

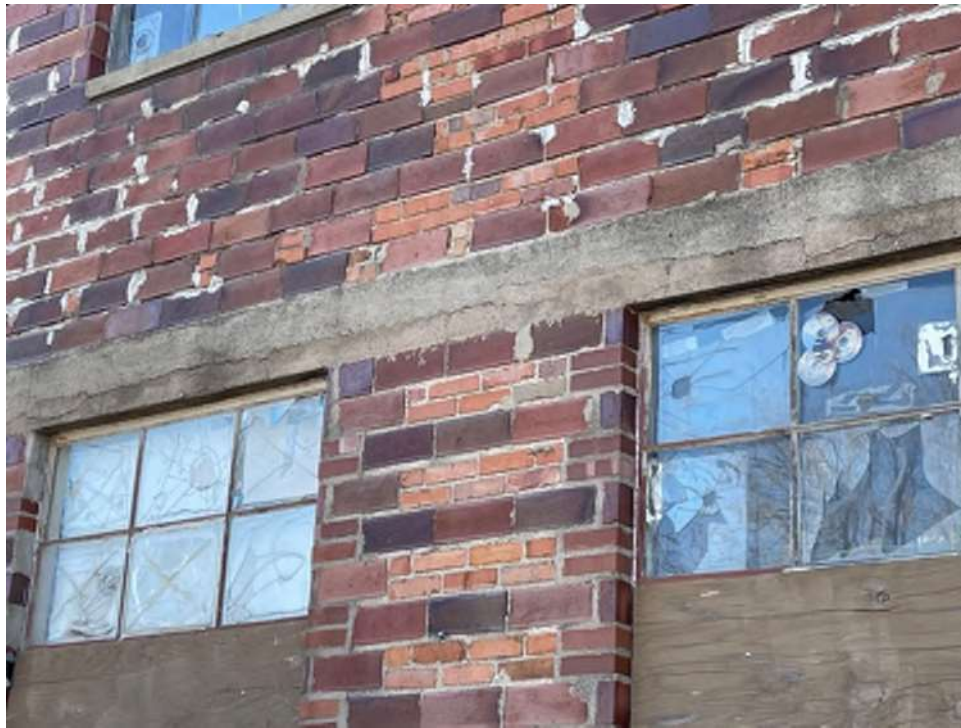
Photo 12 - Lateral cracking in concrete beam/lintel. Eventually will worsen and concrete will fall away

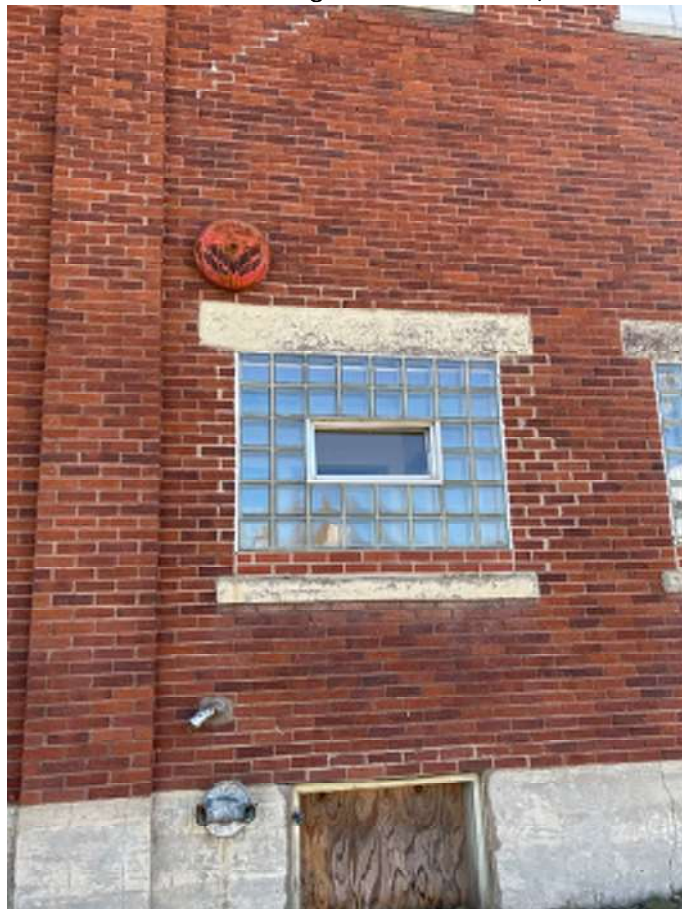
Photo 13 – Front brick facade with previous repairs to brick and mortar joints

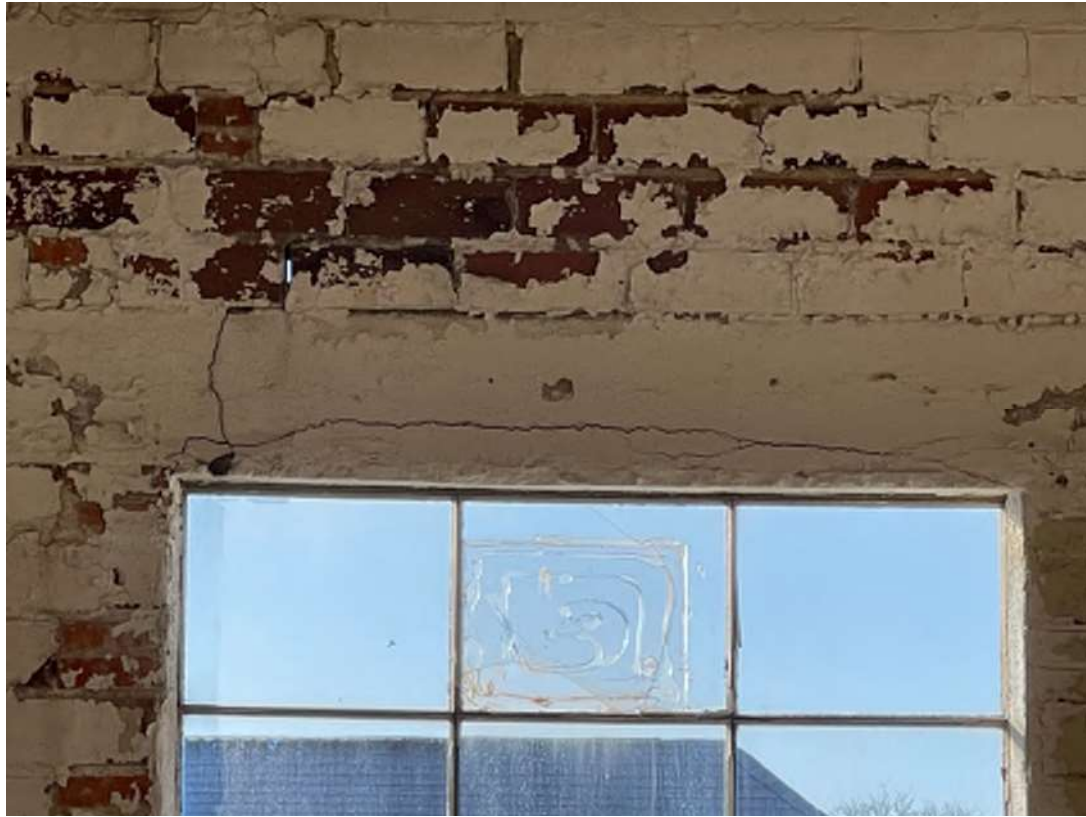
Photo 14 – Interior view of cracking at concrete support beam/lintel

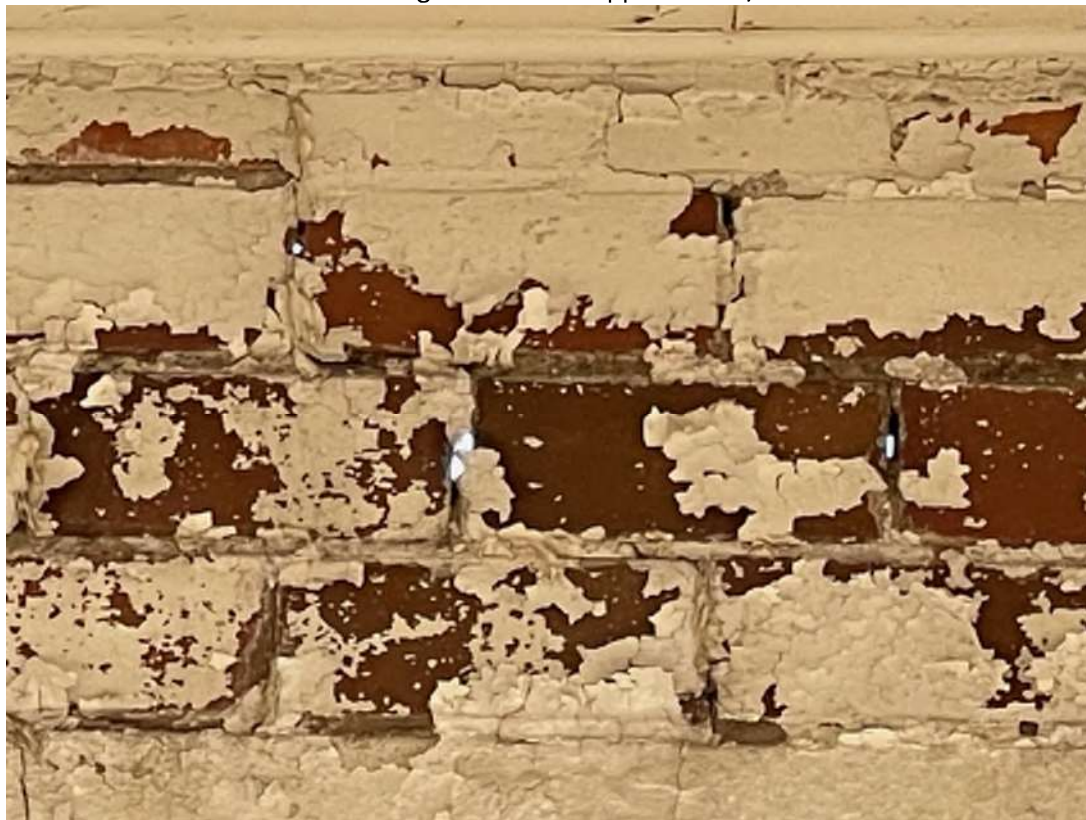
Photo 15 - Mortar deterioration, and gaps in brick showing daylight

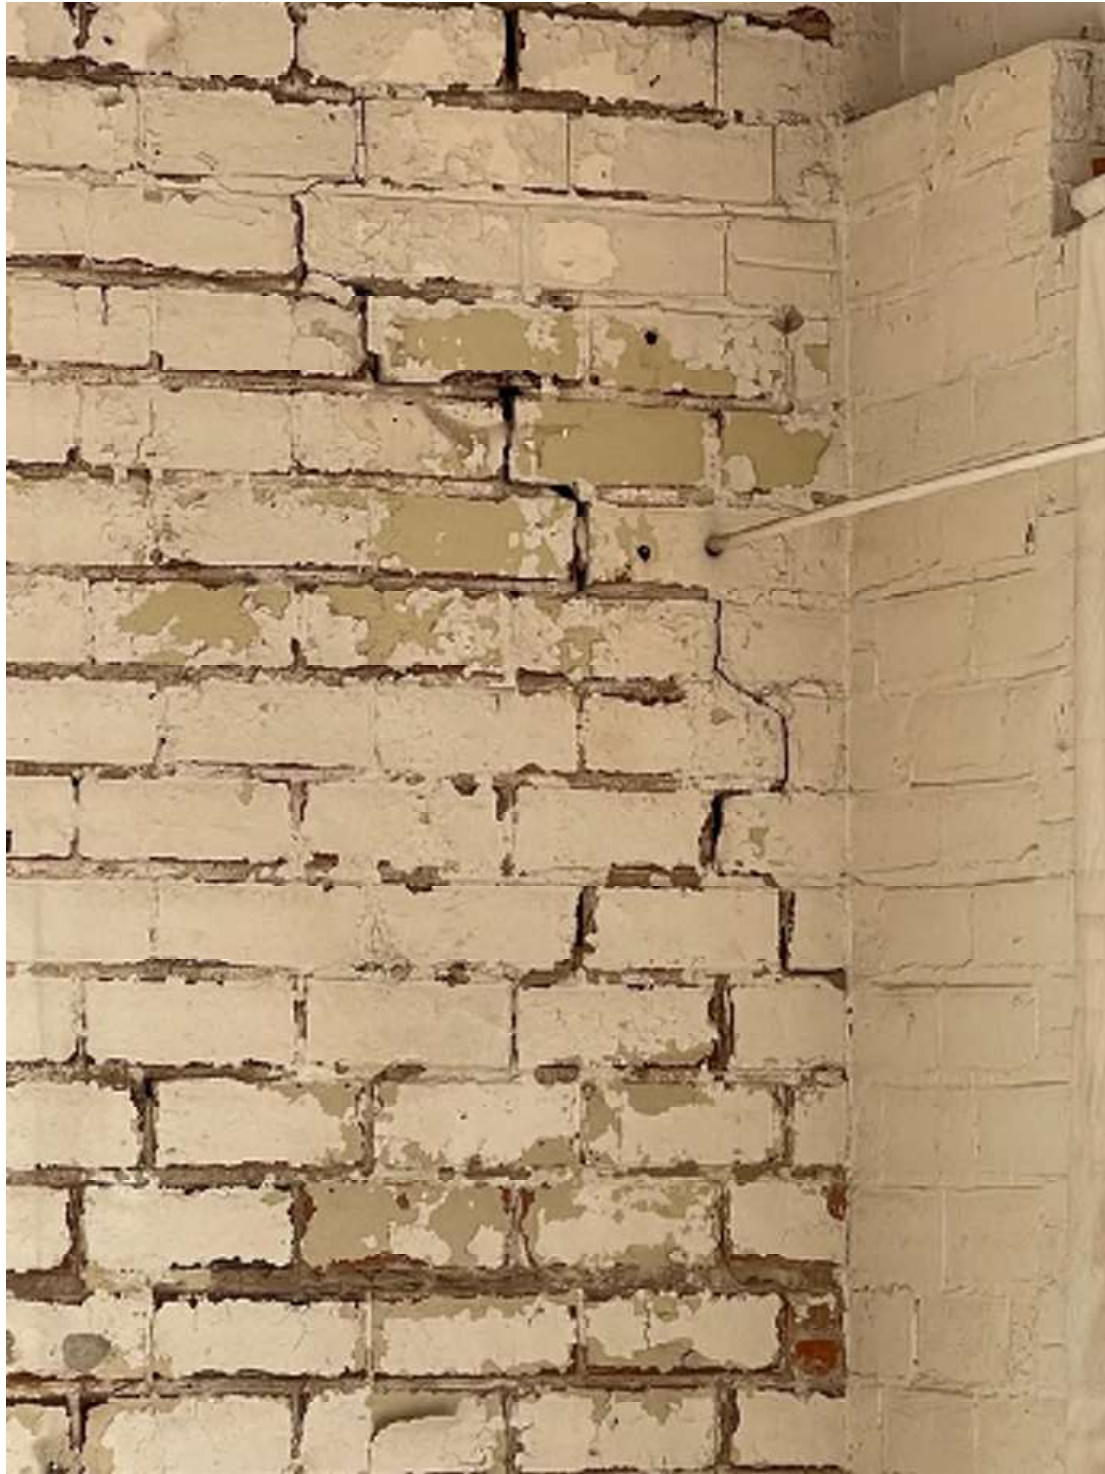
Photo 16 - Vertical stair stepped crack at Southwest corner due to settlement

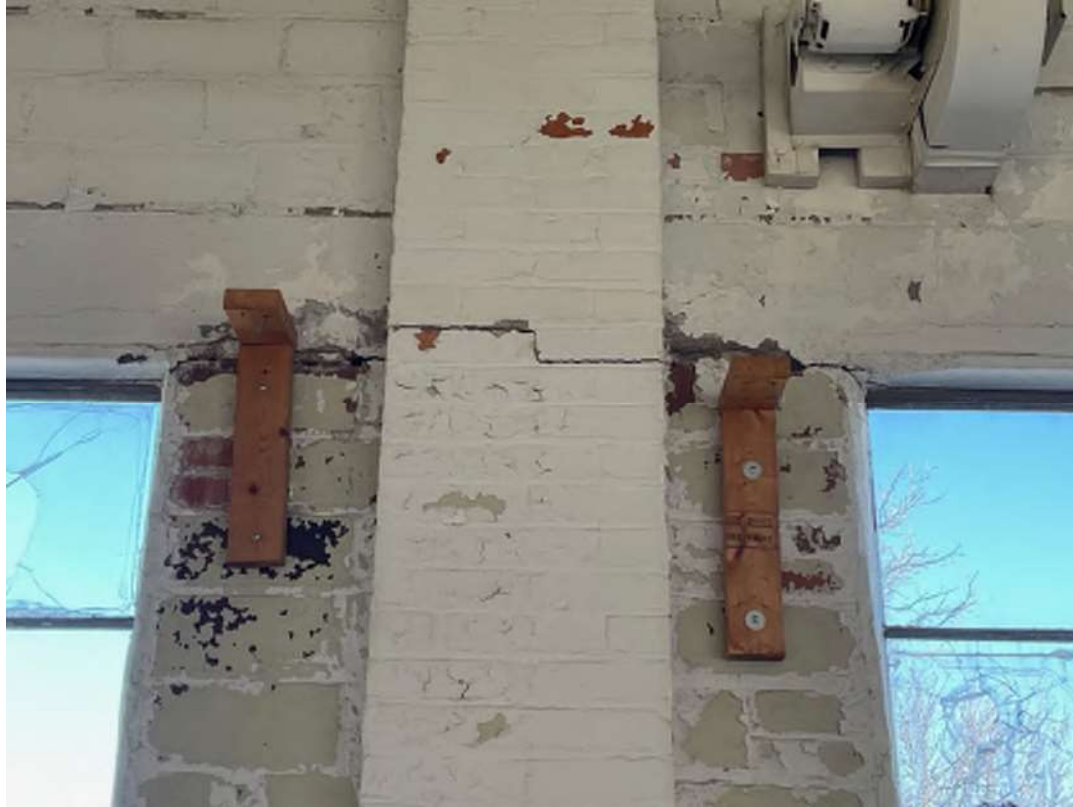
Photo 17 - Crack at concrete beam/lintel on outside is showing through the brick pilaster on the inside

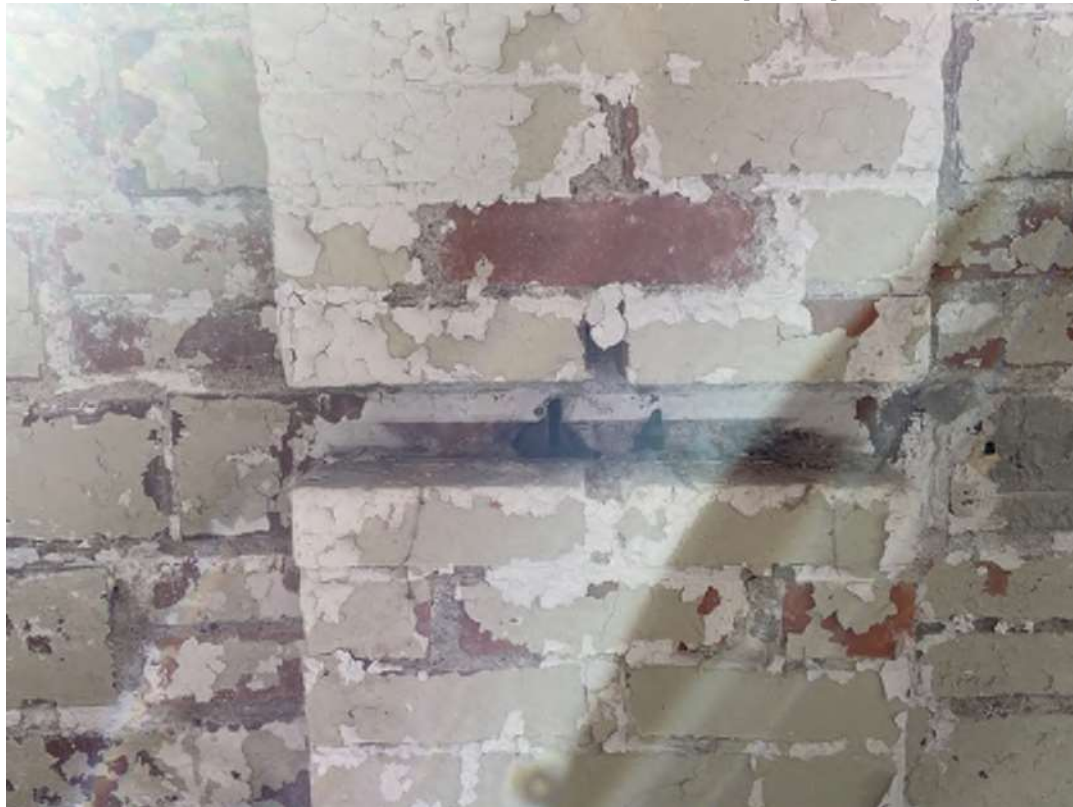
Photo 18 – Bricks removed from pilaster/pier likely to install electrical conduit. Recommend replace

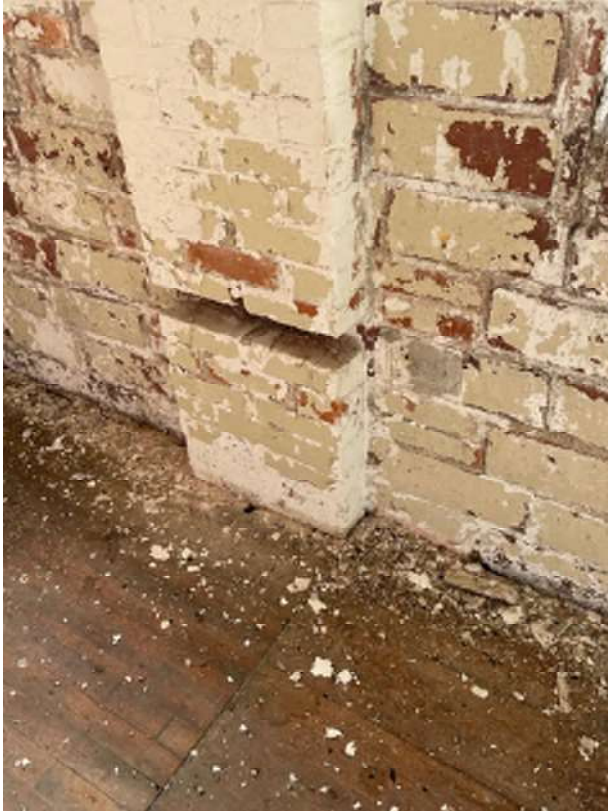
Photo 19 – Additional gap in missing brick pilaster

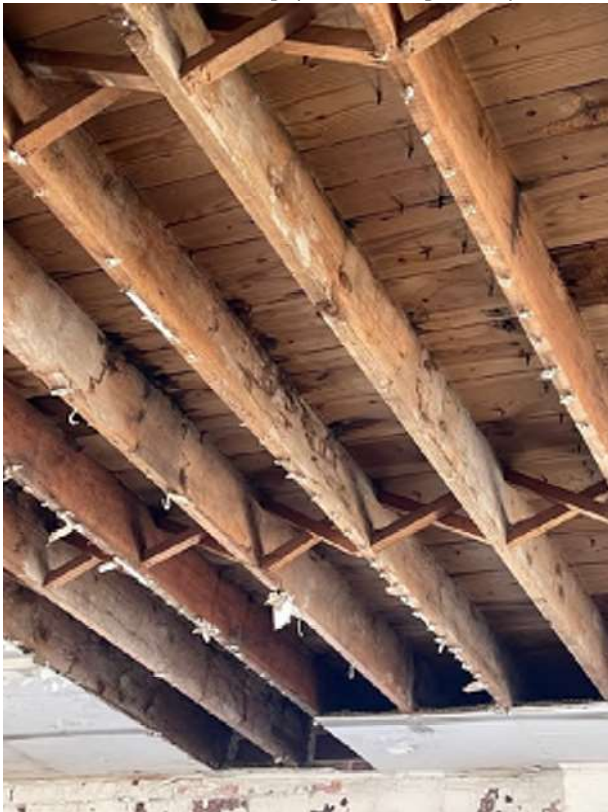
Photo 20 - 2x10 Roof joists @ 16"o.c. with x-bridging. Light water staining, but in good condition

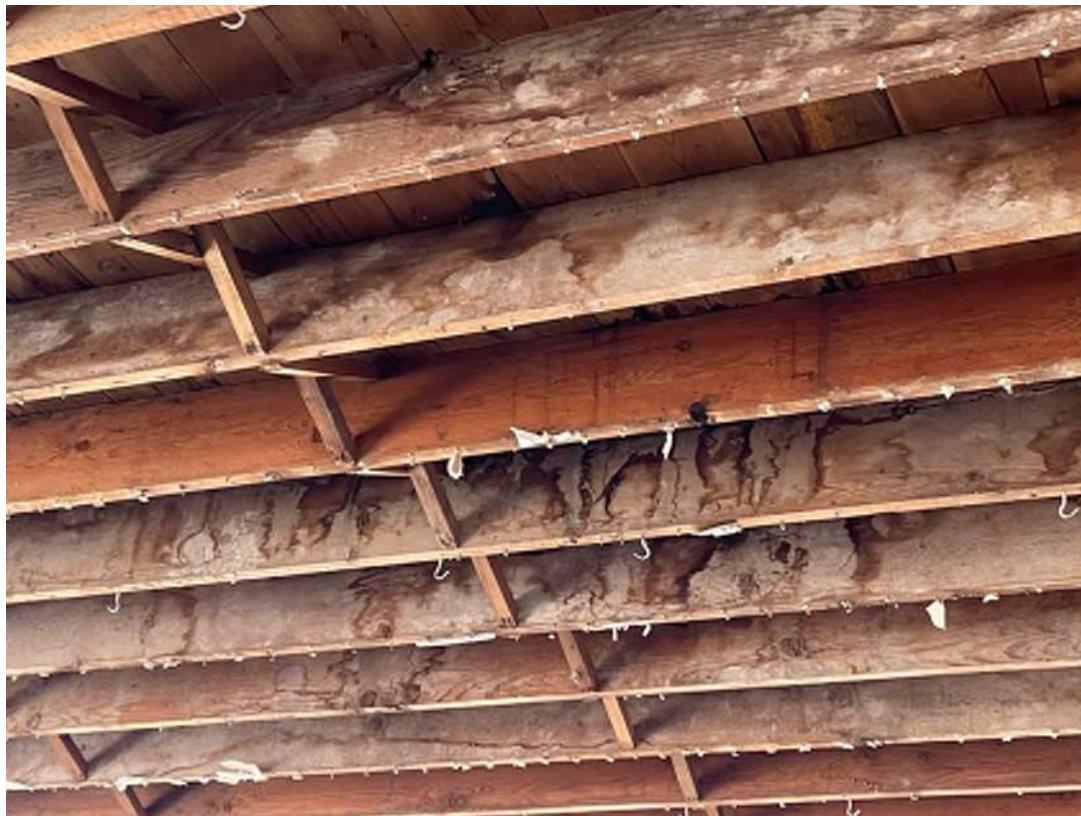
Photo 21 - Water staining found on roof joists, but no apparent structural damage from rot
