# SITE REVISIONING PLAN

107 NORTH GARNAVILLO STREET  
ANAMOSA, IOWA

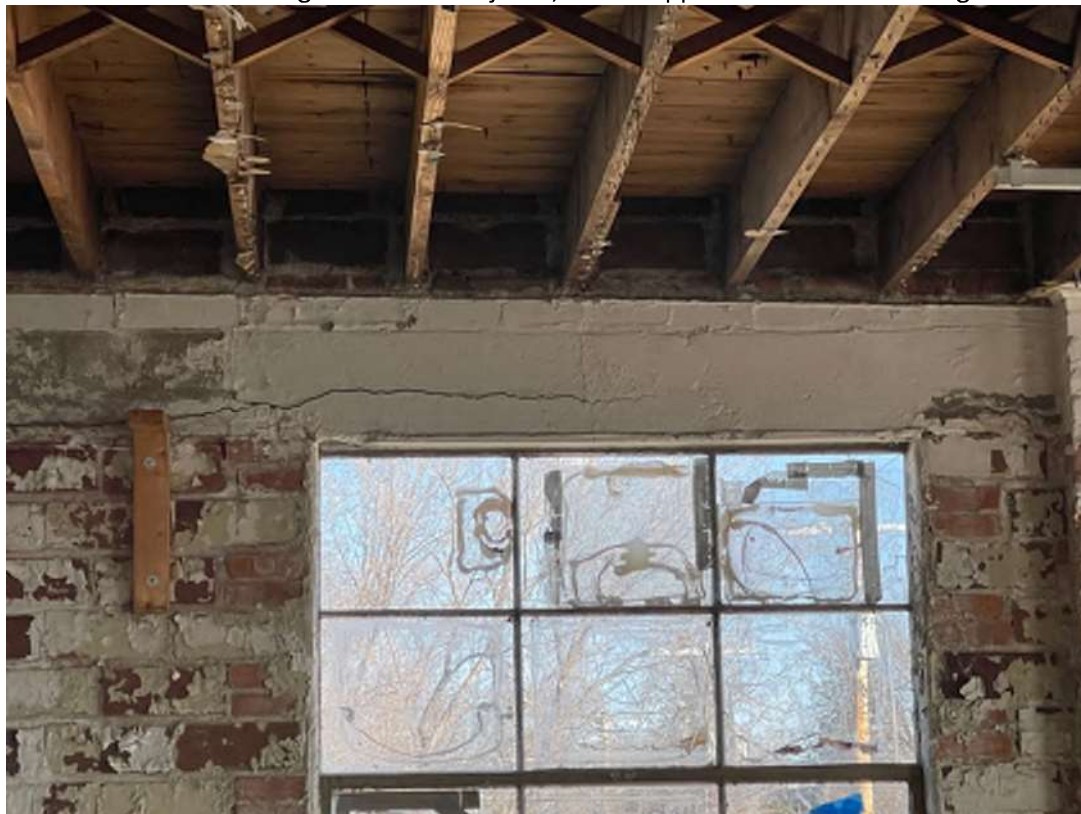
Photo 22 - Roof 2x10 joist nearing on cracked concrete beams and lintels over the windows

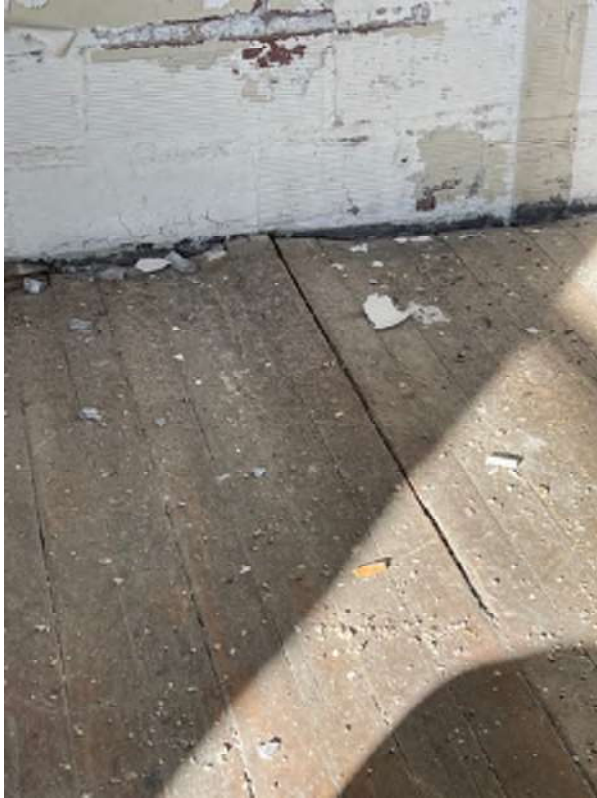
Photo 24 - Buckling of hardwood flooring due to previous roof leak. Structure not visible for review. Hardwood floor covering non-structural.

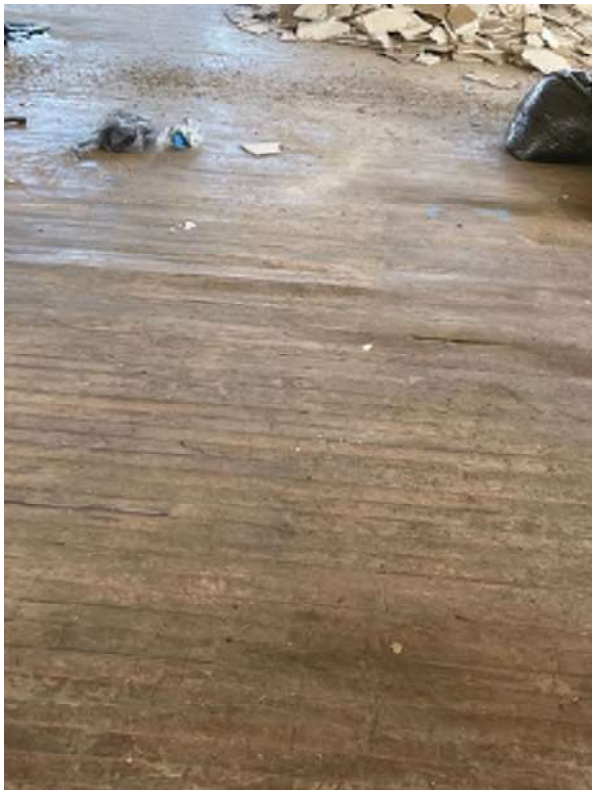
Photo 25 - Minor warping and buckling in wood floor boards due to previous roof leaks

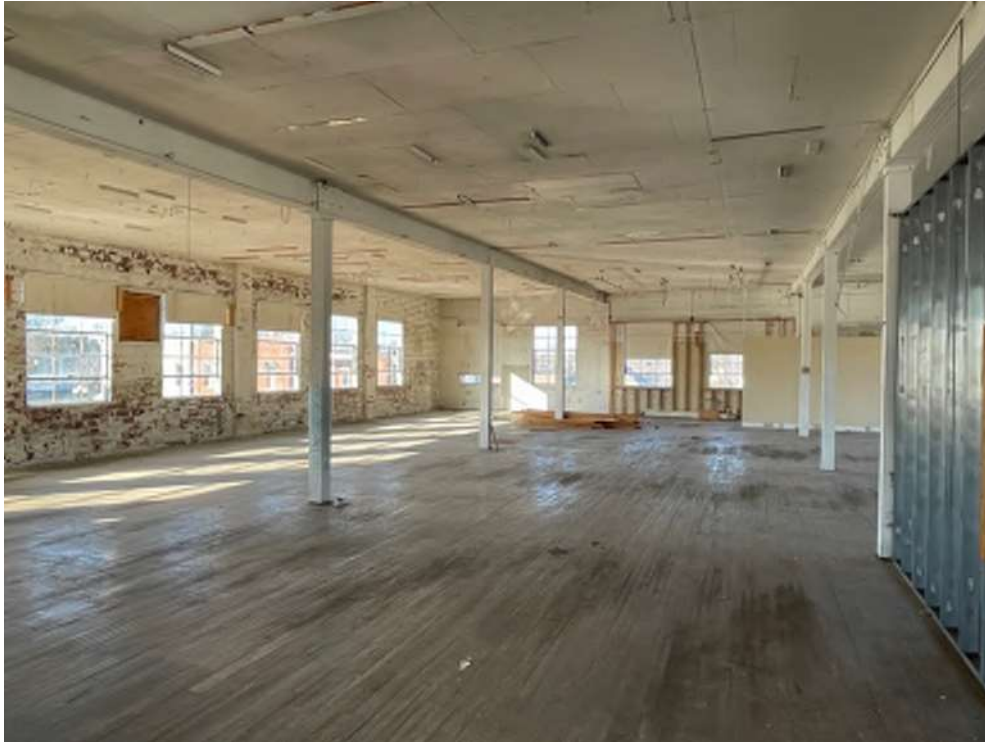
Photo 26 - Overall view of second floor ceiling looking West with column and beam lines running down the center of the building. Much of the ceiling/roof structure in this area was covered with paneling.

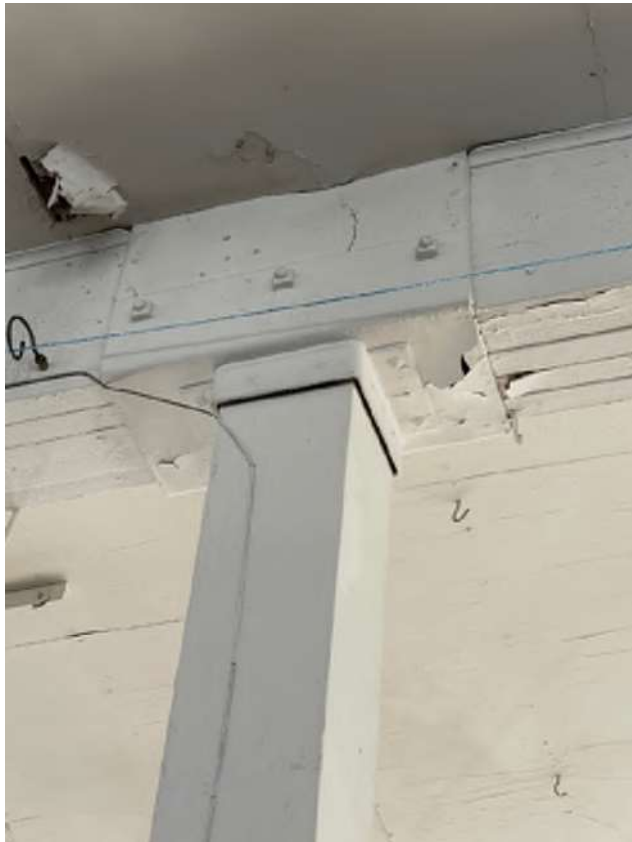
Photo 27 - Steel bracket and saddle found at the beam to column connections. Good condition

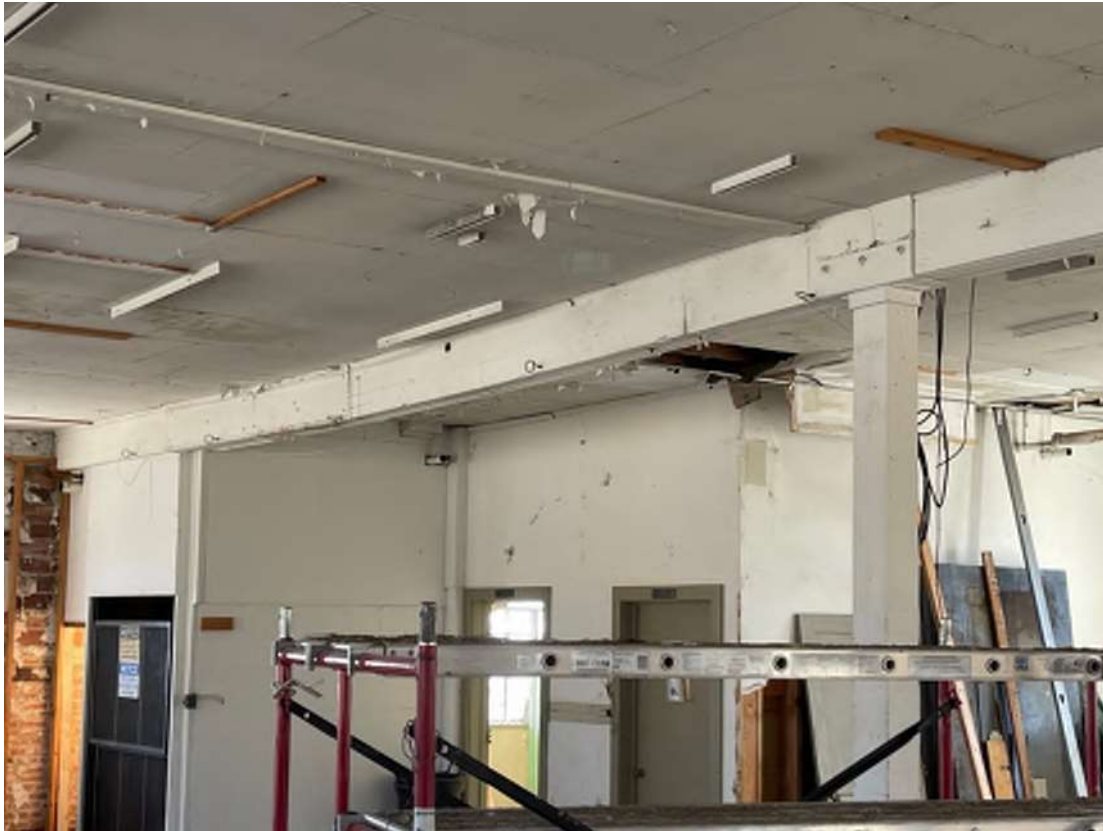
Photo 28 - Sagging beam found at the East end supporting the roof near the elevator shaft. Evidence of former mechanical equipment hung from the ceiling in this area may have overloaded the beam, coupled with water from roof leak may have caused this sag. Jack back into place and nail 2x to each side of the beam as reinforcement.

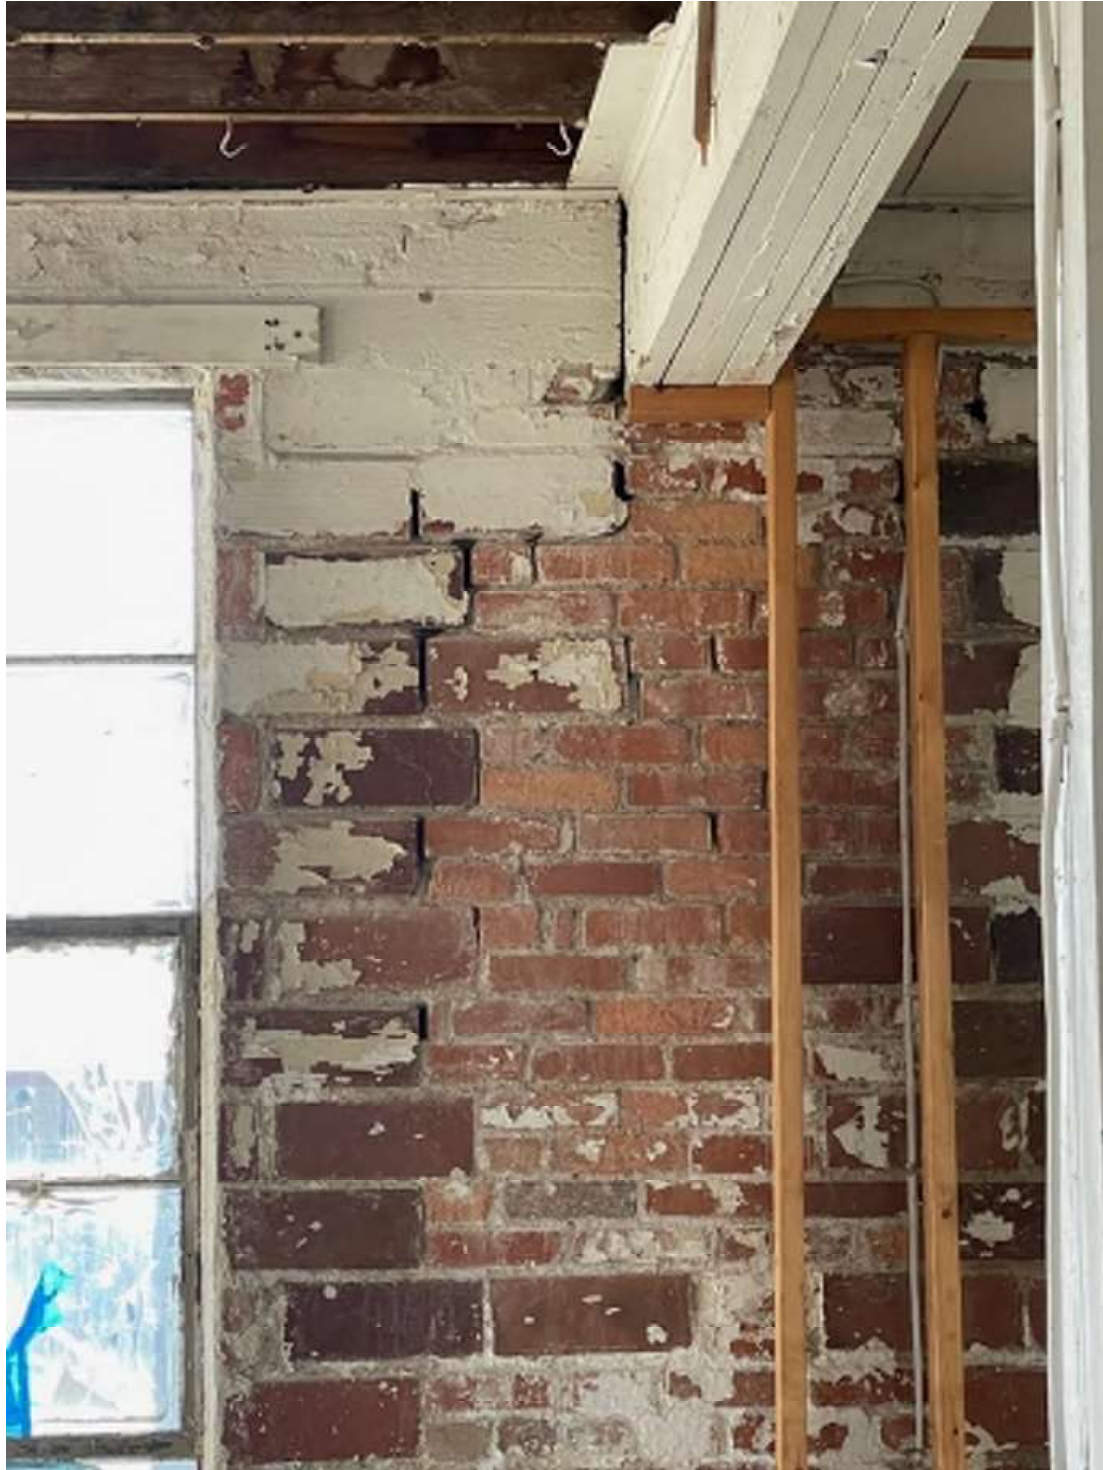
Photo 29 - Roof beam pocketed into masonry wall. Loose bricks need repaired.

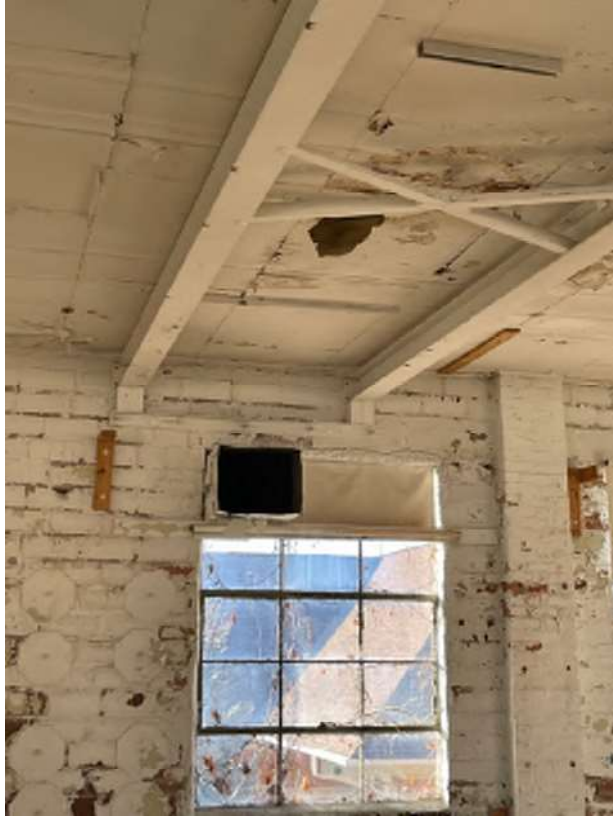
Photo 30 - Steel beam framing from apparent previous machinery support

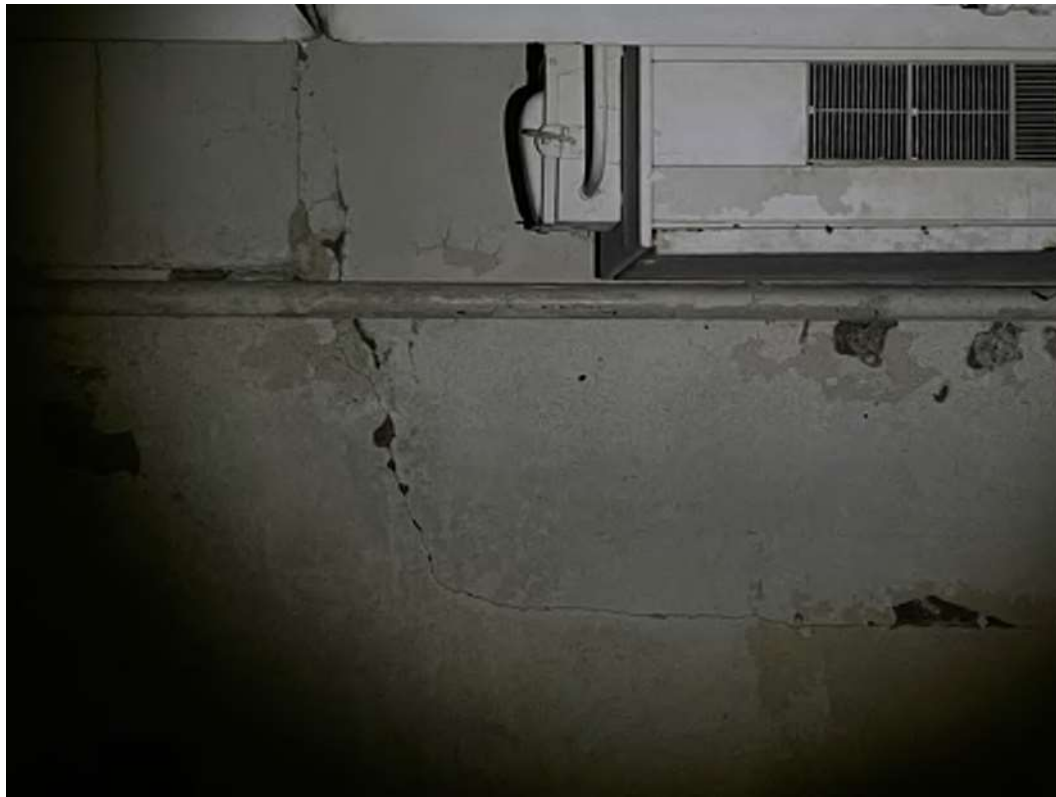
Photo 32 - Cracking of foundation wall in basement Northside wall

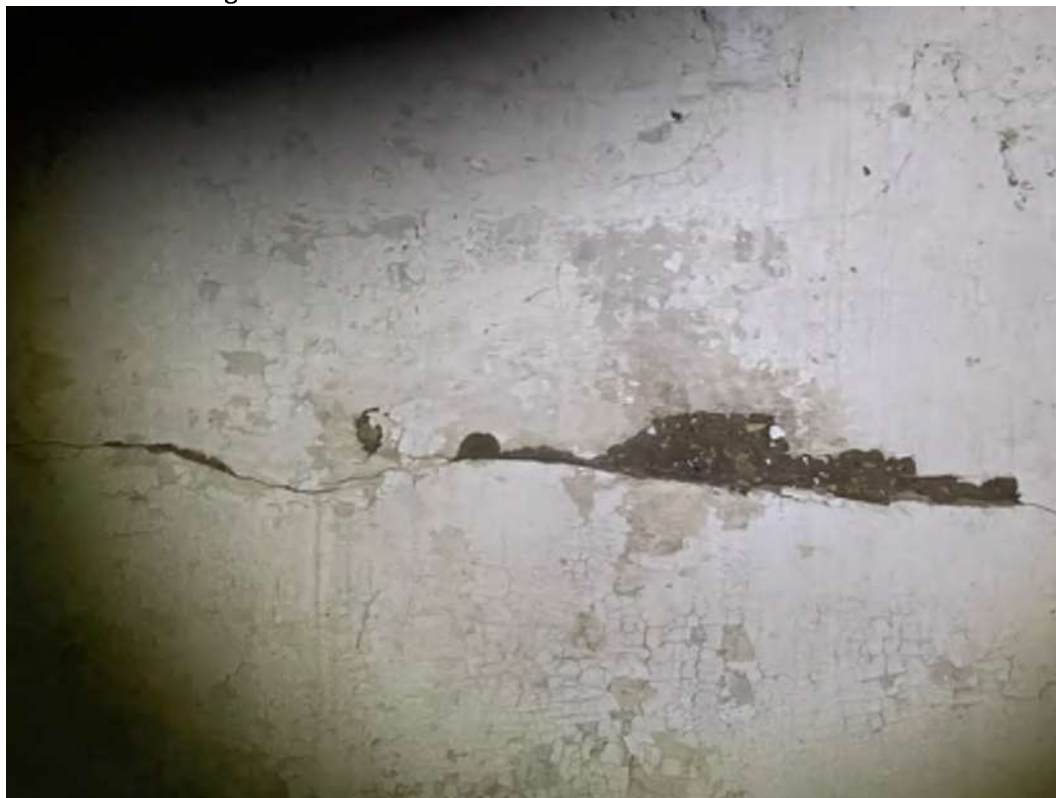
Photo 33 - Cracking of foundation wall in basement Northside wall

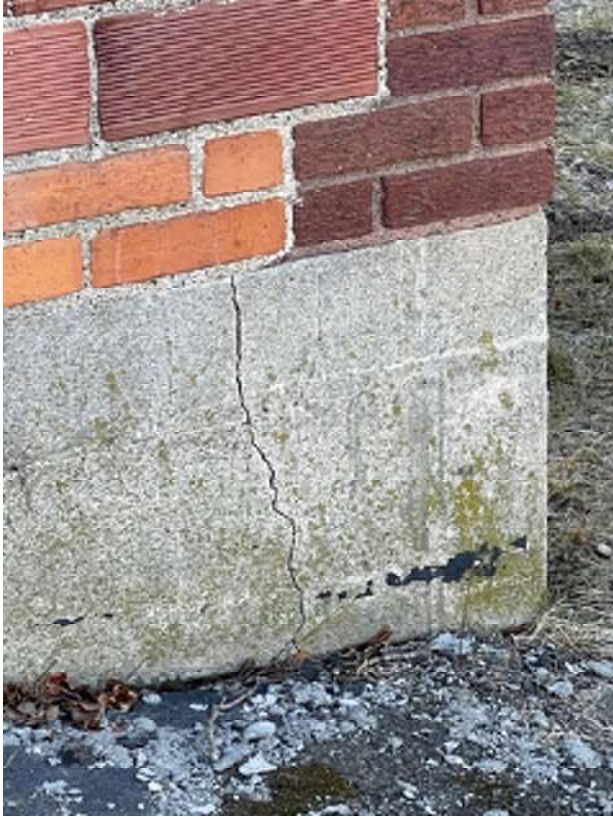
Photo 34 - Vertical settlement crack at building corner

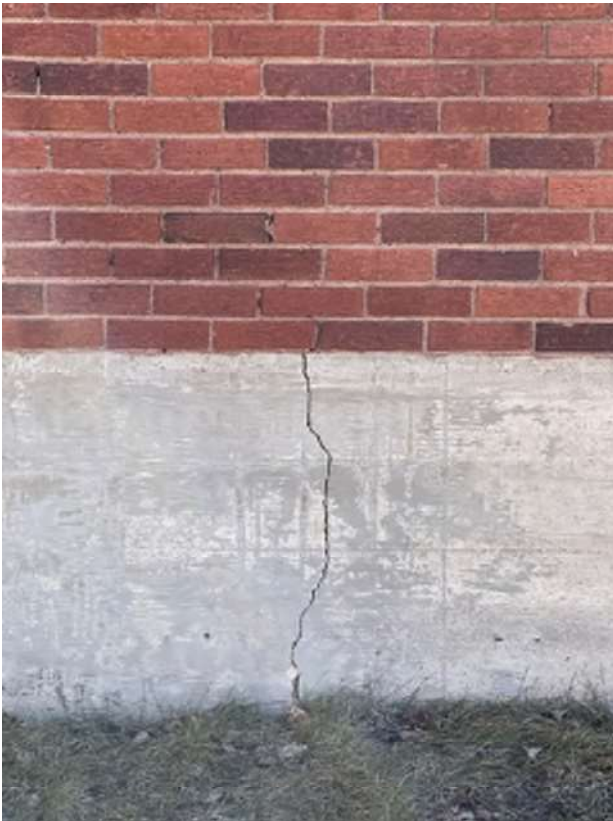
Photo 35 - Vertical cracking at front of building

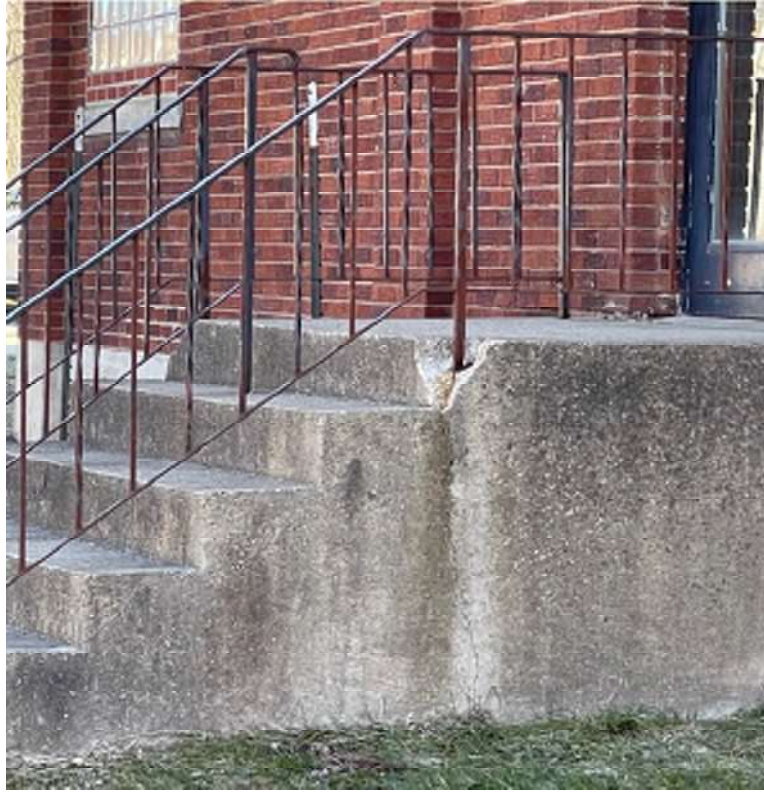
Photo 36 - Spalling of concrete stoop with vertical cracking
