Asbestos Sampling Survey Report

211 and 213 East Broadway Street
Stanwood, Cedar County, Iowa 52337

July 22, 2021

Terracon Project No. 07207086; Task 5

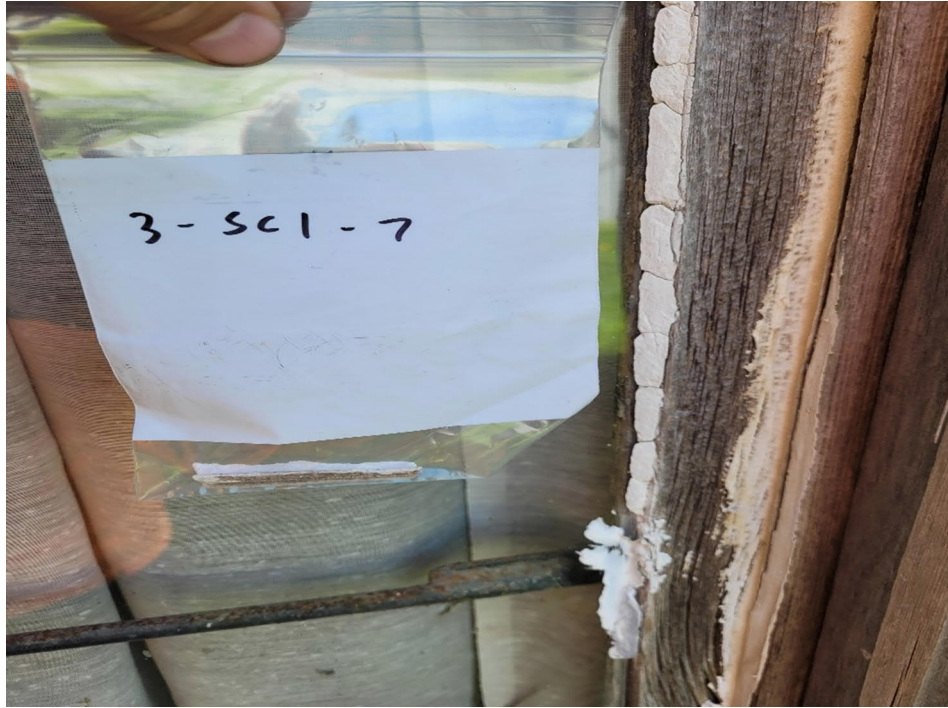
- n Build-up roof – black, gray, and white tar coating (3% Chrysotile) Located on Building 211 roof
- n Window glazing – white (3% Chrysotile) Located on the exterior of the building on older windows

Photo 1: View of positive window glazing

The ACM is considered a Category I nonfriable material and must be removed by a licensed asbestos abatement contractor prior to demolition of the buildings and must be disposed of at an approved landfill.

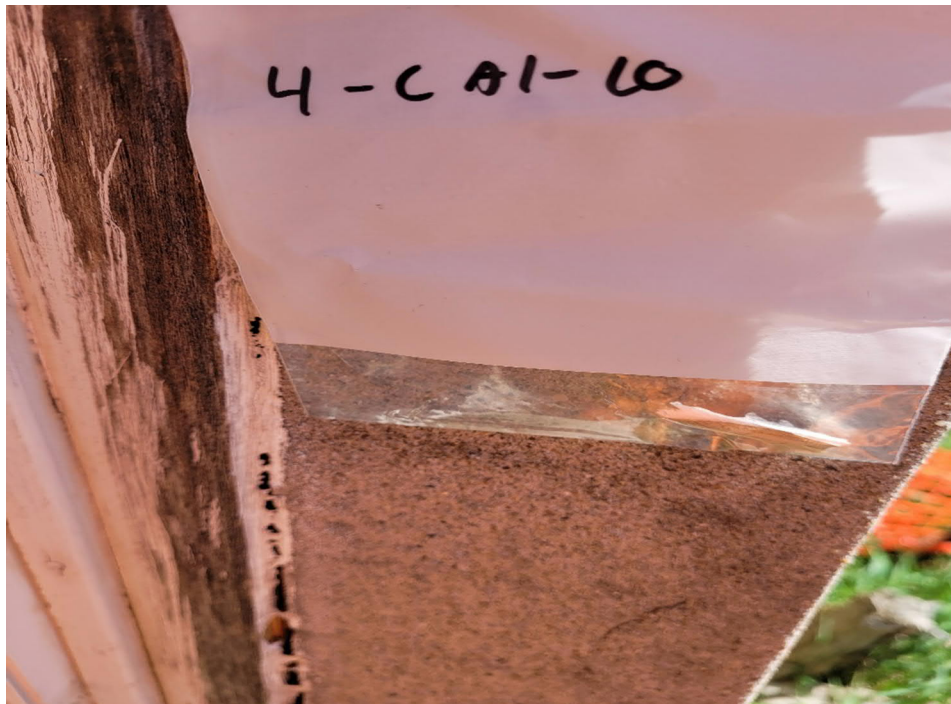
- n Window caulk – white (3% Chrysotile) Located on the exterior of the building around older window openings
- n Vinyl sheet flooring – brown and tan (25% Chrysotile) Located in building 211 north end apartment kitchen

Photo 2: View of positive window caulking

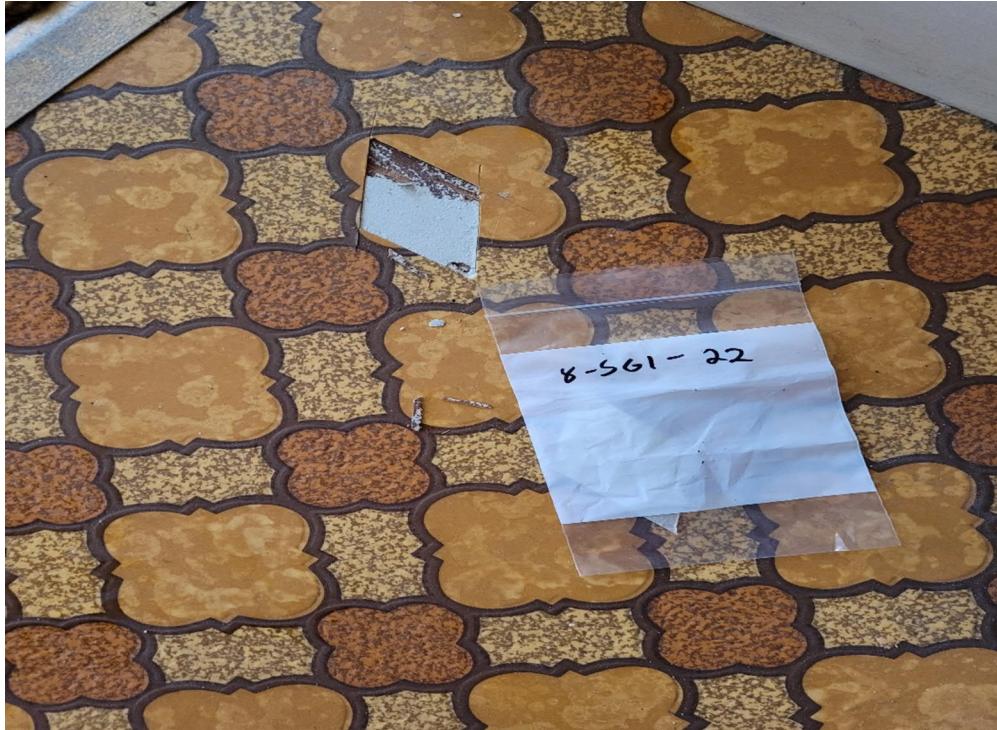
Photo 3: View of positive vinyl sheet flooring in building 211 2nd floor north end apartment kitchen.

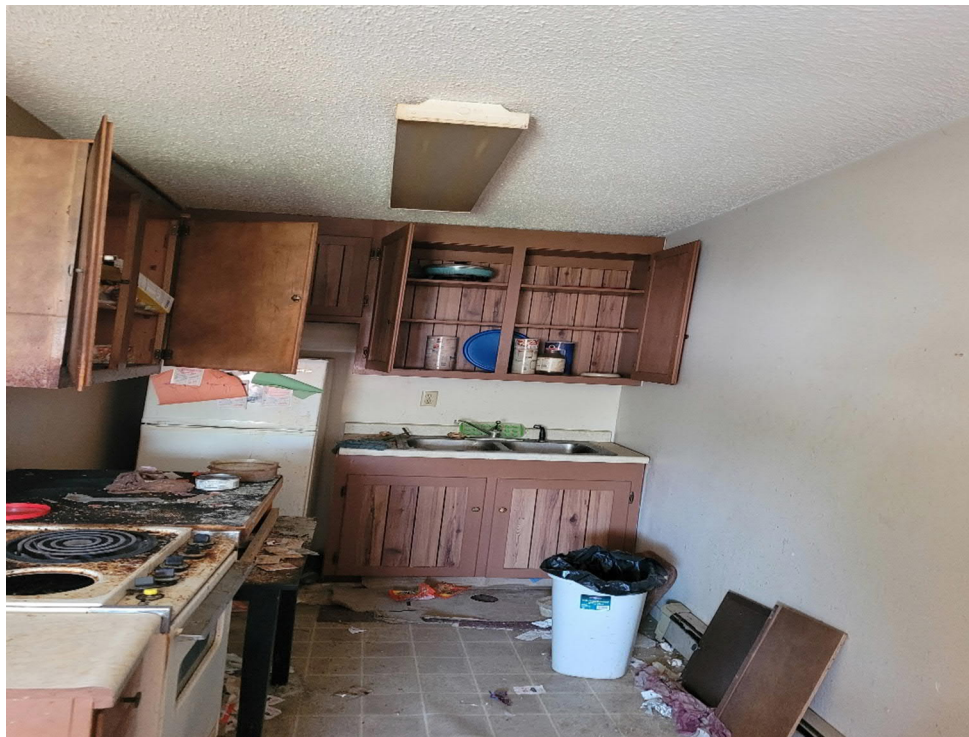
- n Vinyl sheet flooring – brown square pattern (25% Chrysotile) Located in building 211 South end apartment kitchen
- n Vinyl sheet flooring – off-white/gray squared pattern (20% Chrysotile) Located in 213 north end apartment bathroom

Photo 4: View of positive vinyl sheet flooring 2 layers in building 211 2nd floor south end apartment kitchen.

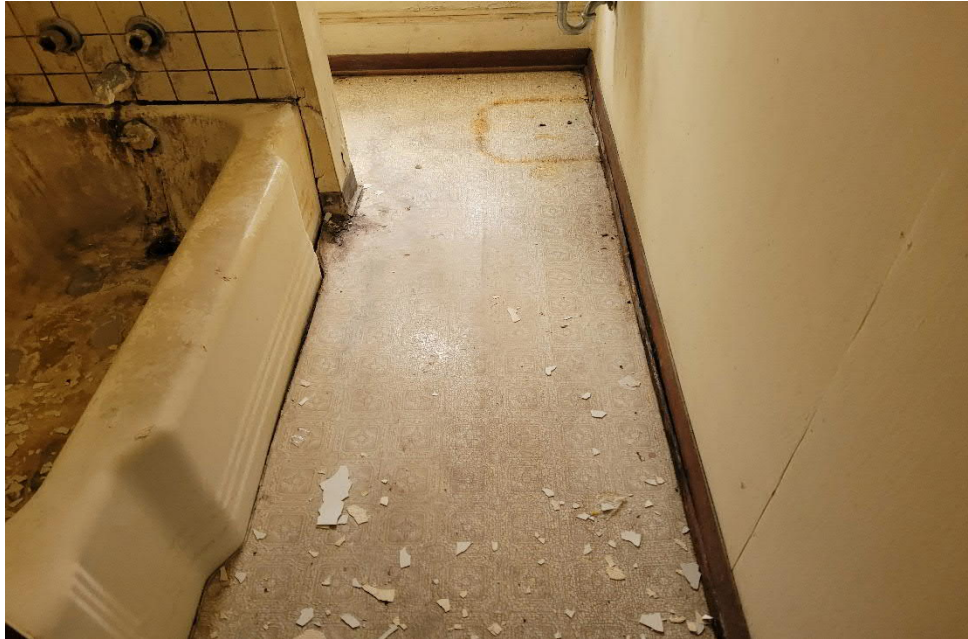
Photo 5: View of positive vinyl sheet flooring in bathroom of building 213 2nd floor apartment.

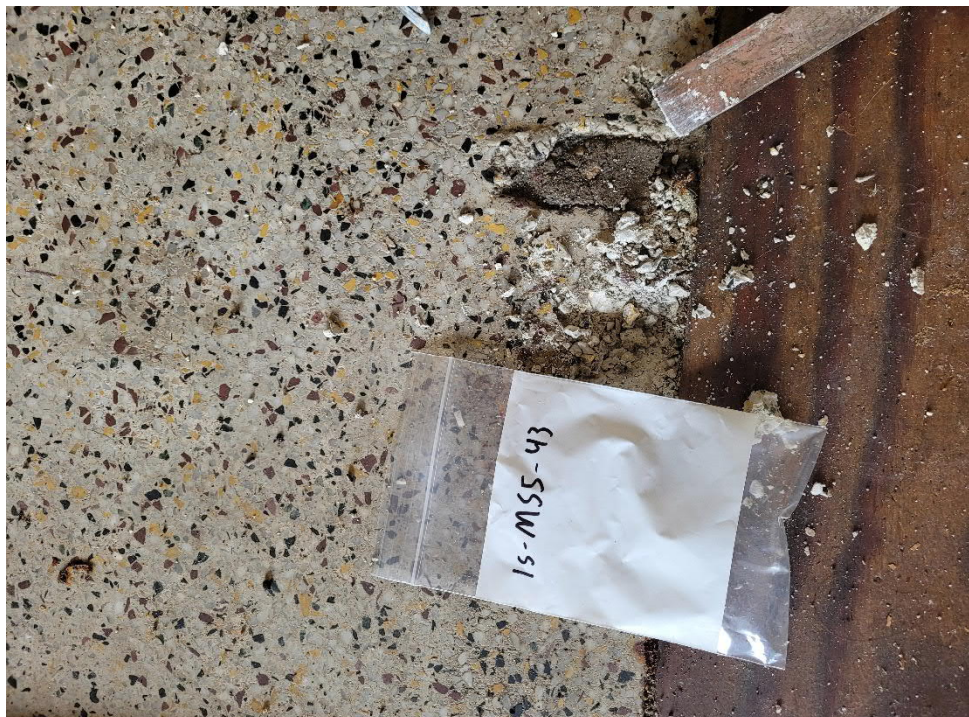
- n Terrazzo flooring (3% Chrysotile) Located in building 213 1st floor path ways
- n Vinyl sheet flooring – off-white/gray with streaks (20% Chrysotile) Located in 211 1st floor office on east side of building in bathroom

Photo 6: View of positive terrazzo flooring in building 213 1st floor office space.

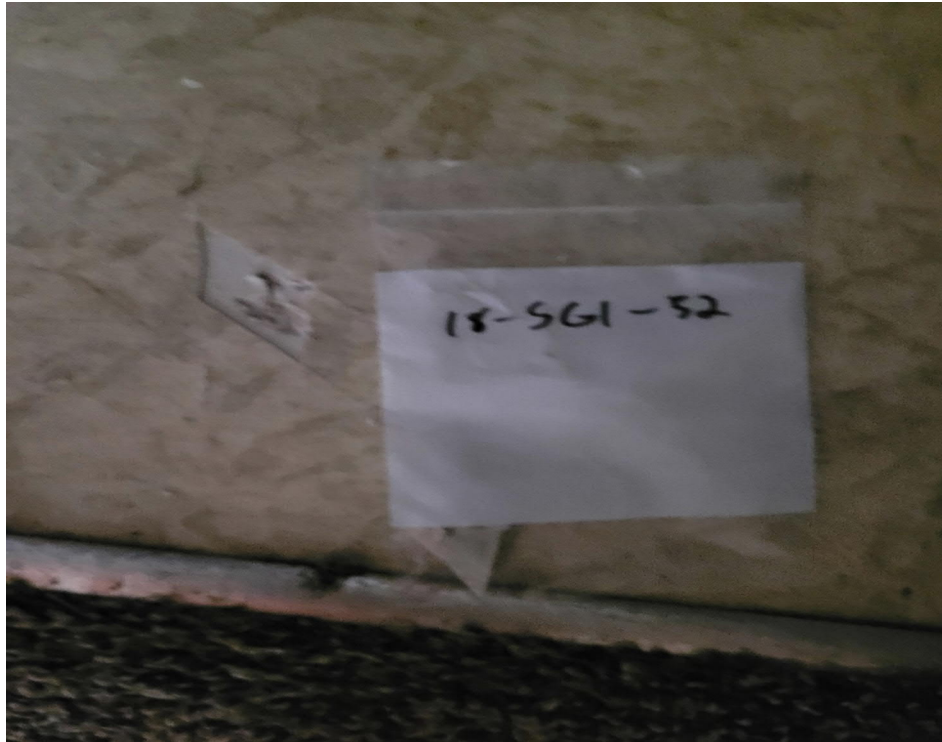
Photo 7: View of positive vinyl sheet flooring in building 211 1st floor east side office bathroom.

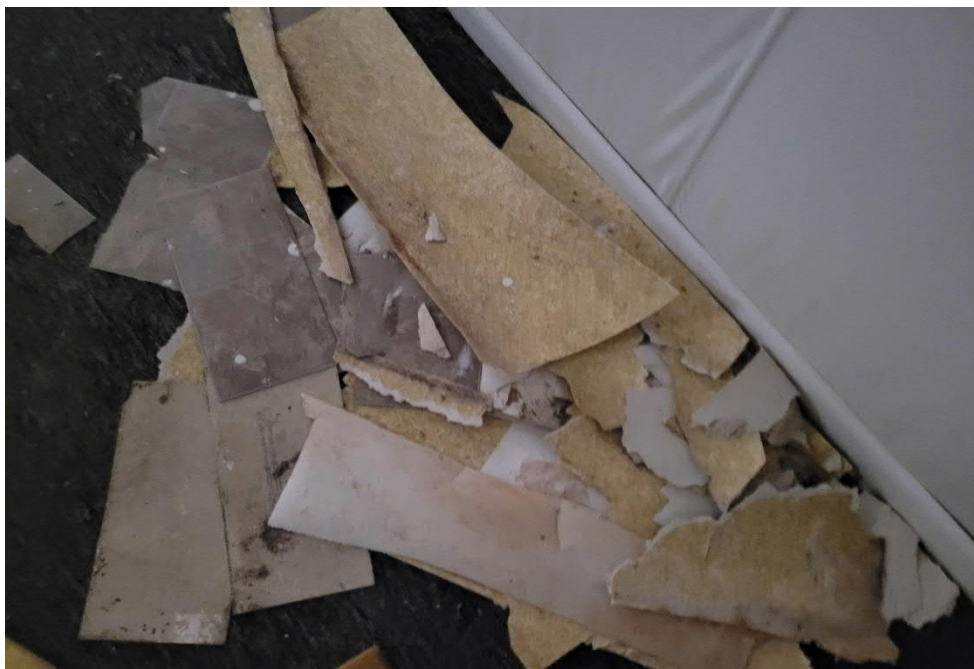
- n Vinyl sheet flooring – yellow, pebble pattern (20% Chrysotile) Located in 211 1st floor office on west side of building in bathroom and middle room

Photo 8: View of positive vinyl sheet flooring debris pile in building 211 1st floor west side office located in middle room and under carpet and shower.

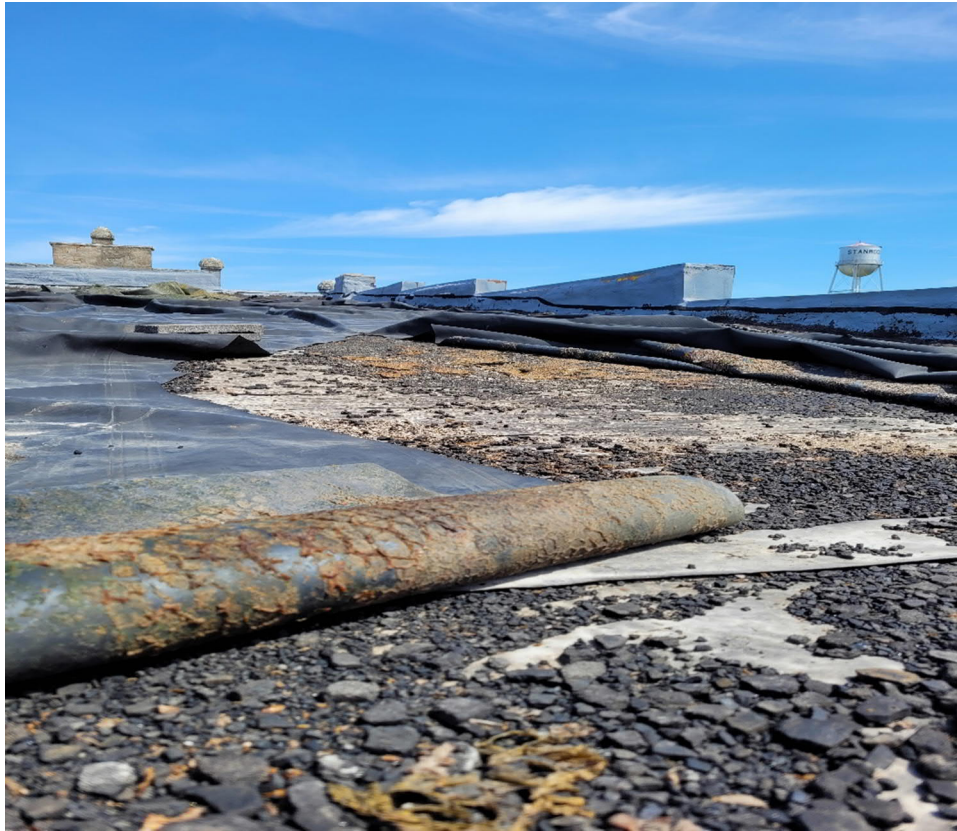
- n Roof flashing – black, gray, and white coating (3% Chrysotile) Located on building 213 roof, south end flashing
- n Build-up roof – black, gray with brown fibrous insulation (8-10%Chrysotile) Located on building 213 roof

Photo 9: View of positive roof decking and flashing throughout both building roofs.
