# SITE REVISIONING PLAN

107 NORTH GARNAVILLO STREET  
ANAMOSA, IOWA

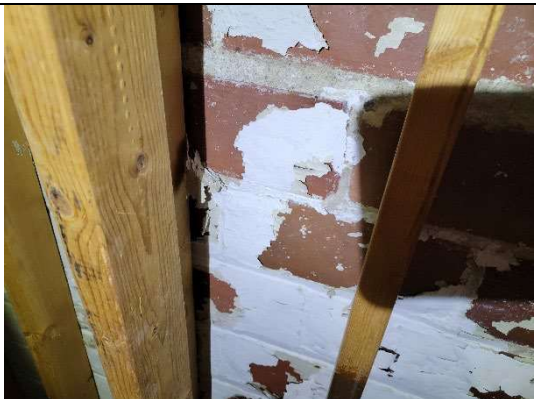
Back entrance of Subject Property structure on east face facing south.		Peeling paint on stairs from ground level to 2 <sup>nd</sup> floor. On east side of the structure.

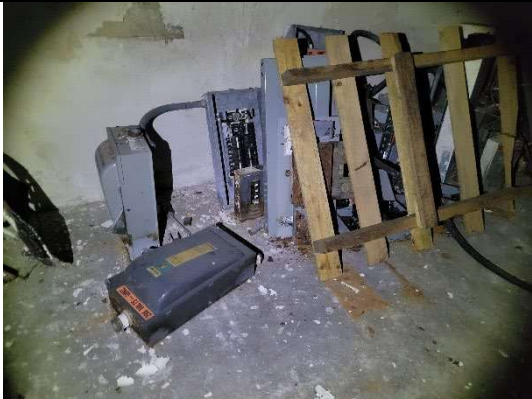
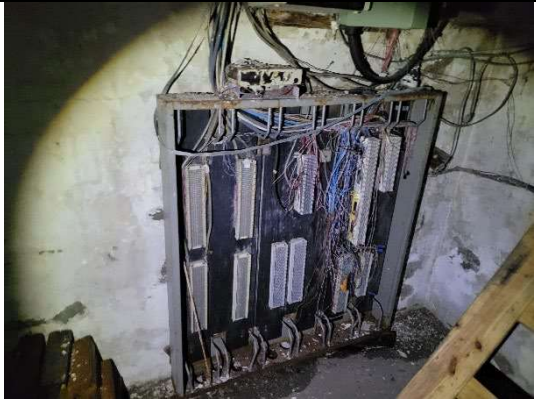
Transformer box pile in northeast corner of basement.		Transformer box in northeast corner of basement.

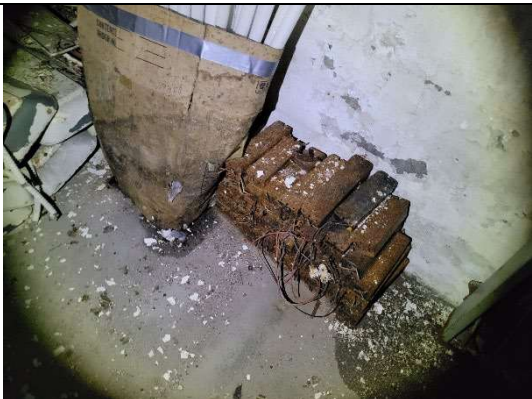
Fuse boxes or radio components stacked in northeast corner of basement.

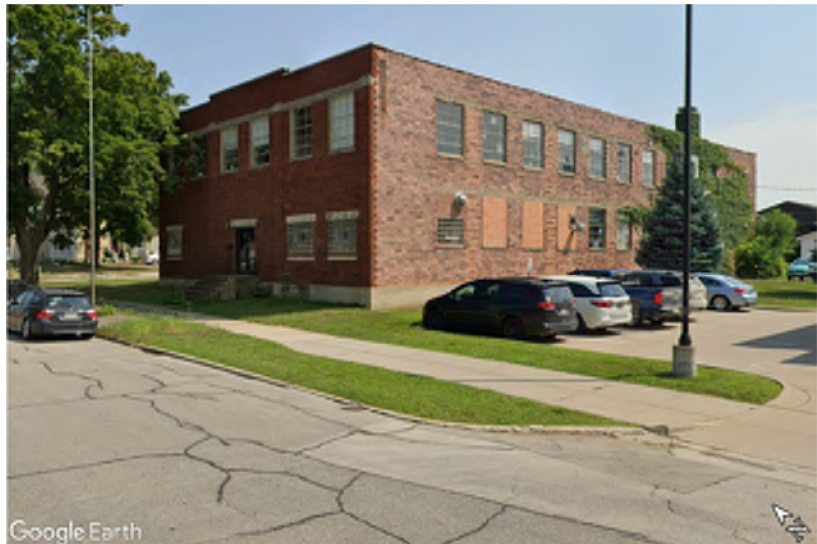
The structure is comprised of structural clay tile exterior walls with a brick front and two stories of wood framed floors with a roof. The basement is poured in placed concrete walls that are half in the ground and half out of the ground. The structural clay tile masonry and brick façade act as bearing walls to support the floor and roof systems. Formed and cast in place concrete lintels were used as support above the windows. The floor and roof systems are constructed of sawn lumber 2x wood framing with a line of wood beams and columns running longitudinally.

The front exterior is a brick façade which is in relatively good condition. Signs of previous brick joint tuckpointing and replacement bricks can be seen around the windows.

The clay masonry exterior walls on the North, South and rear of the building have experienced severe deterioration of the mortar joints to the point that gaps can be found with light showing through the wall in spots. The concrete lintels (support beams) above the windows have severely deteriorated due to moisture to the point that the steel reinforcing bars are exposed, and the surrounding concrete is spalling and falling away.

The most severe need is attention to the exterior masonry walls, specially tuckpointing the mortar joints, repairing and replacing loose brick and the concrete support lintels above the windows. The walls and roof should be temporarily shored during this repair and the masonry restoration contractor should work in sections, not replacing an entire side at once. Because the concrete lintels are split, they are reduced in capacity and weakened. During a high windstorm event they may not hold up or be stable.

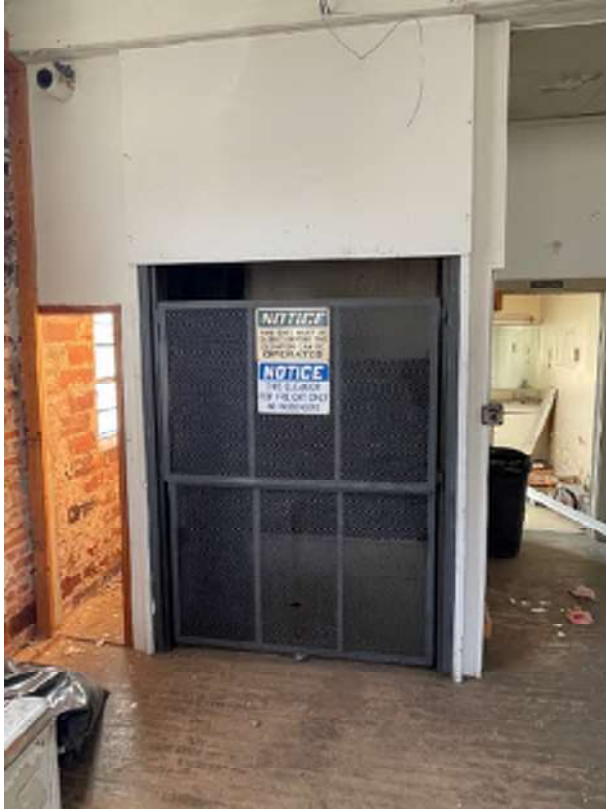
Photo 1 - Freight Elevator Located in Southeast Corner. Was not operable at time of inspection and the structure was covered with limited areas to see. Consult with an elevator company about the possibility of re-using this.

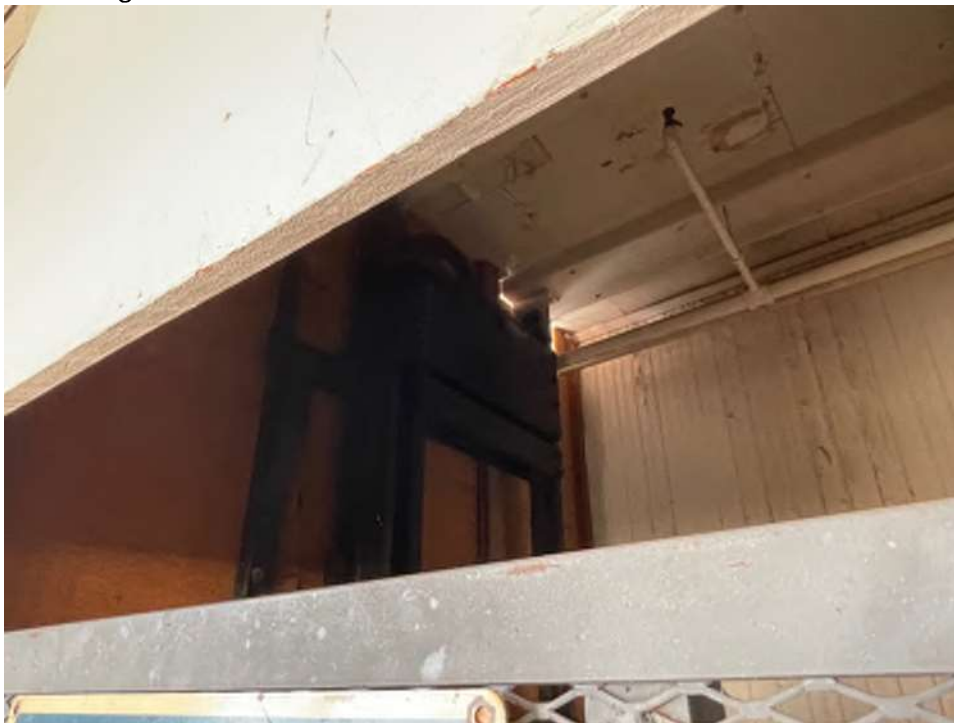
Photo 2 – Limited view of Elevator Shaft

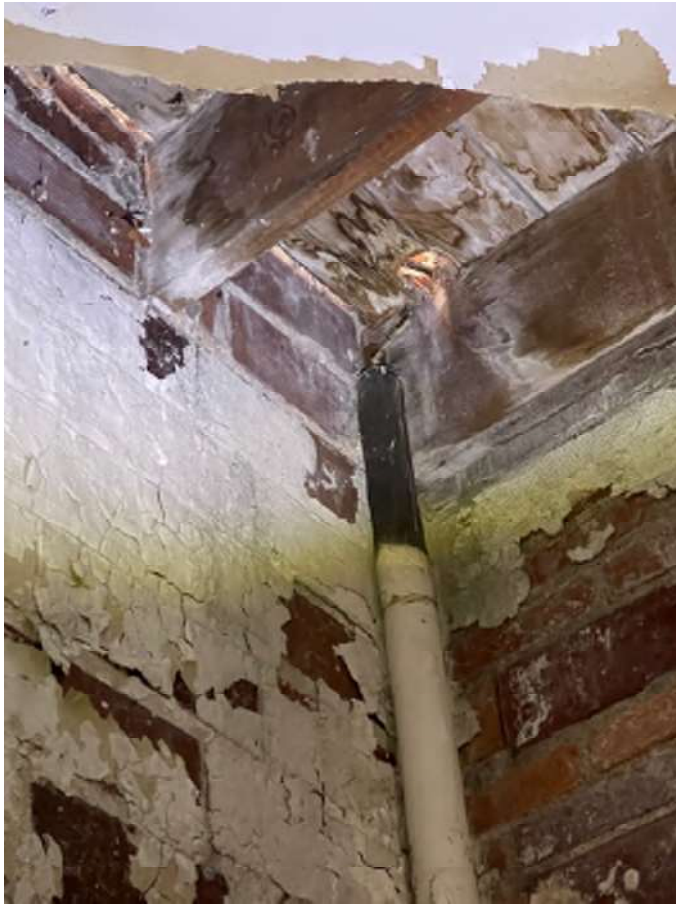
Photo 23 - Second floor 2x12 joist bearing on masonry exterior walls

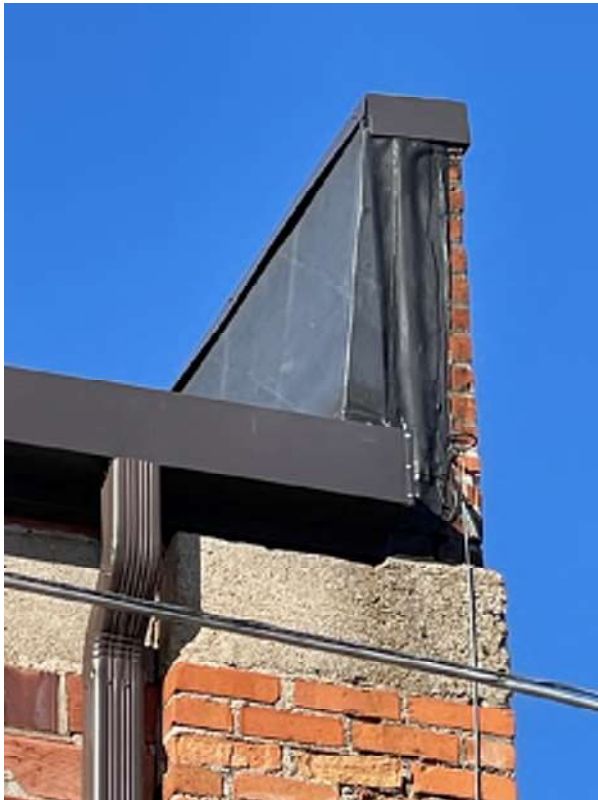
Photo 31 - New roof covering extending up back side of parapet
